AS "BMGS"		Commissioner: Piestatnu Nr.2 un Nr.3 rekonstrukcija	
Site: Ventspils brivostas parvalde		Test Location: Cpt16 Date: 06.09.2013.	Abs. quota [cm]: 230
Locality: Dzintaru iela 51b un 51/3, Ventspils			Prehole [cm]: 220
			Hydrostatic Line [cm]: 200

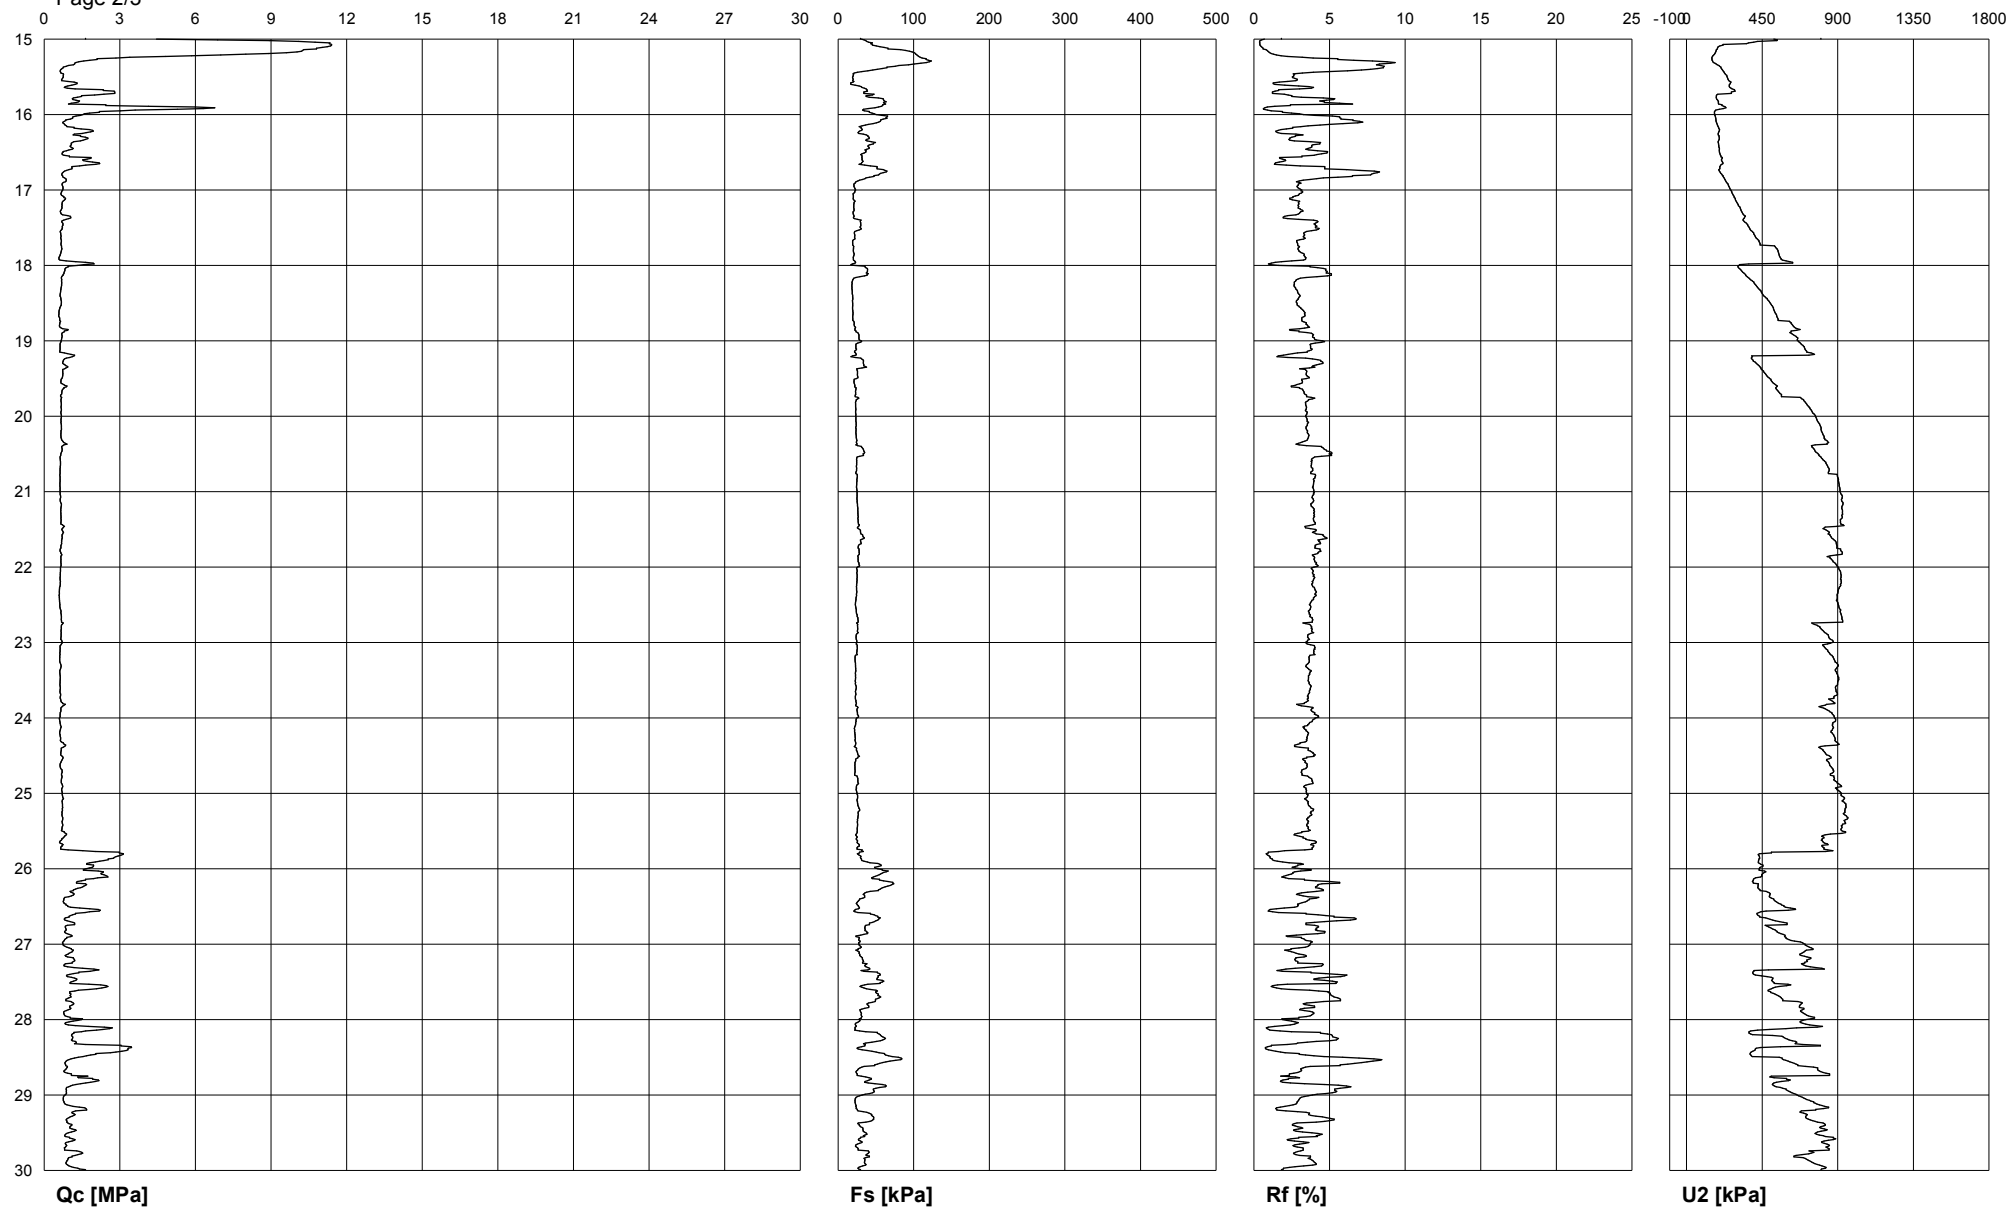
Page 2/3

AS "BMGS"**Commissioner: Piestatnu Nr.2 un Nr.3 rekonstrukcija**Site: Ventspils brivostas parvalde
Locality: Dzintaru iela 51b un 51/3, VentspilsTest Location: Cpt16
Date: 06.09.2013.Abs. quota [cm]: 230
Prehole [cm]: 220
Hydrostatic Line [cm]: 200

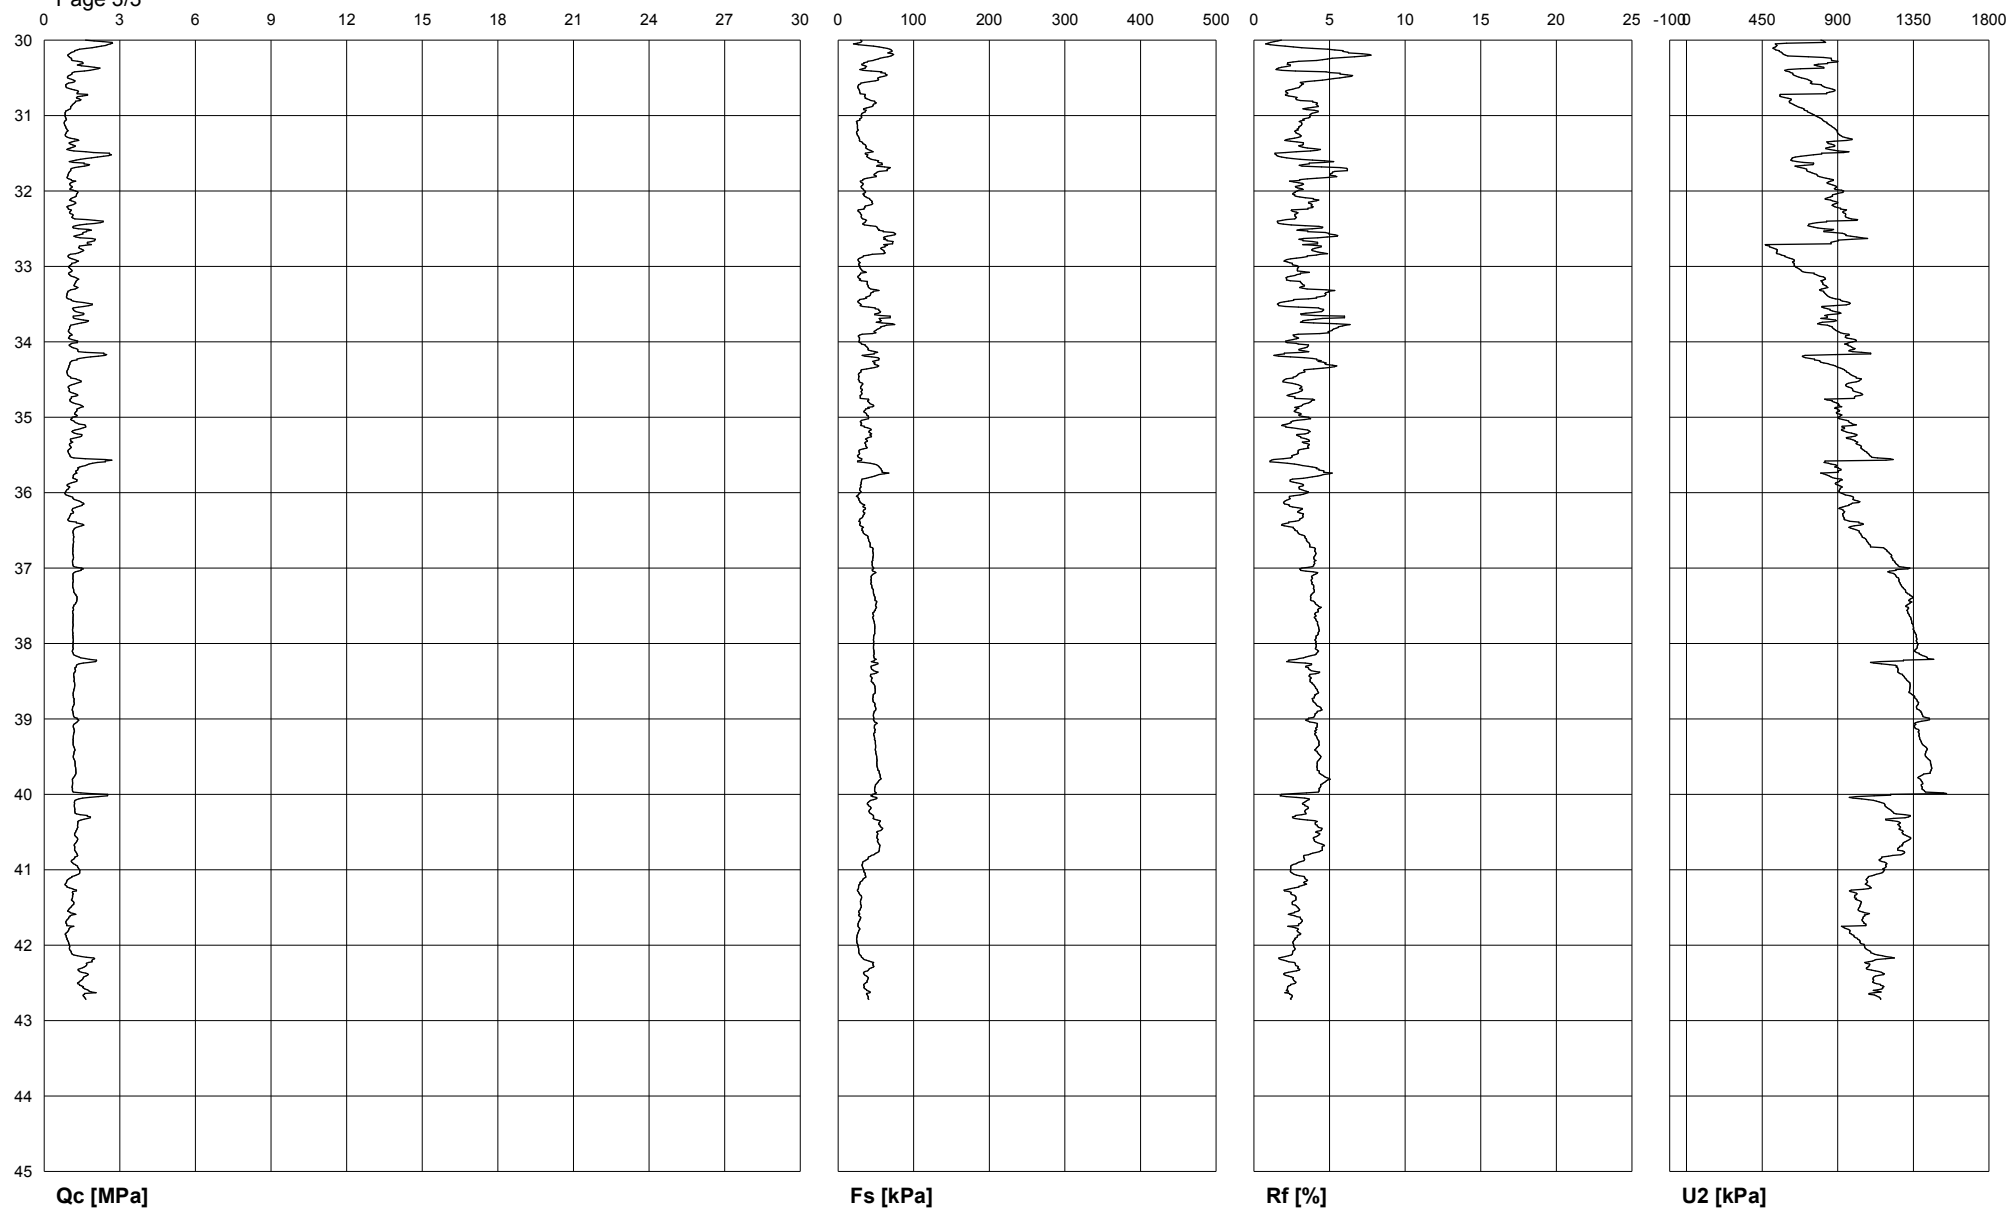
Page 3/3

AS "BMGS"**Commissioner: Piestatnu Nr.2 un Nr.3 rekonstrukcija**Site: Ventspils brivostas parvalde
Locality: Dzintaru iela 51b un 51/3, VentspilsTest Location: Cpt16
Date: 06.09.2013.Abs. quota [cm]: 230
Prehole [cm]: 220
Hydrostatic Line [cm]: 200
