**AS "BMGS"****Commissioner: Piestatnu Nr.2 un Nr.3 rekonstrukcija**Site: Ventspils brivostas parvalde  
Locality: Dzintaru iela 51b un 51/3, VentspilsTest Location: Cpt22  
Date: 13.09.2013.Abs. quota [cm]: 230  
Prehole [cm]: 220  
Hydrostatic Line [cm]: 200

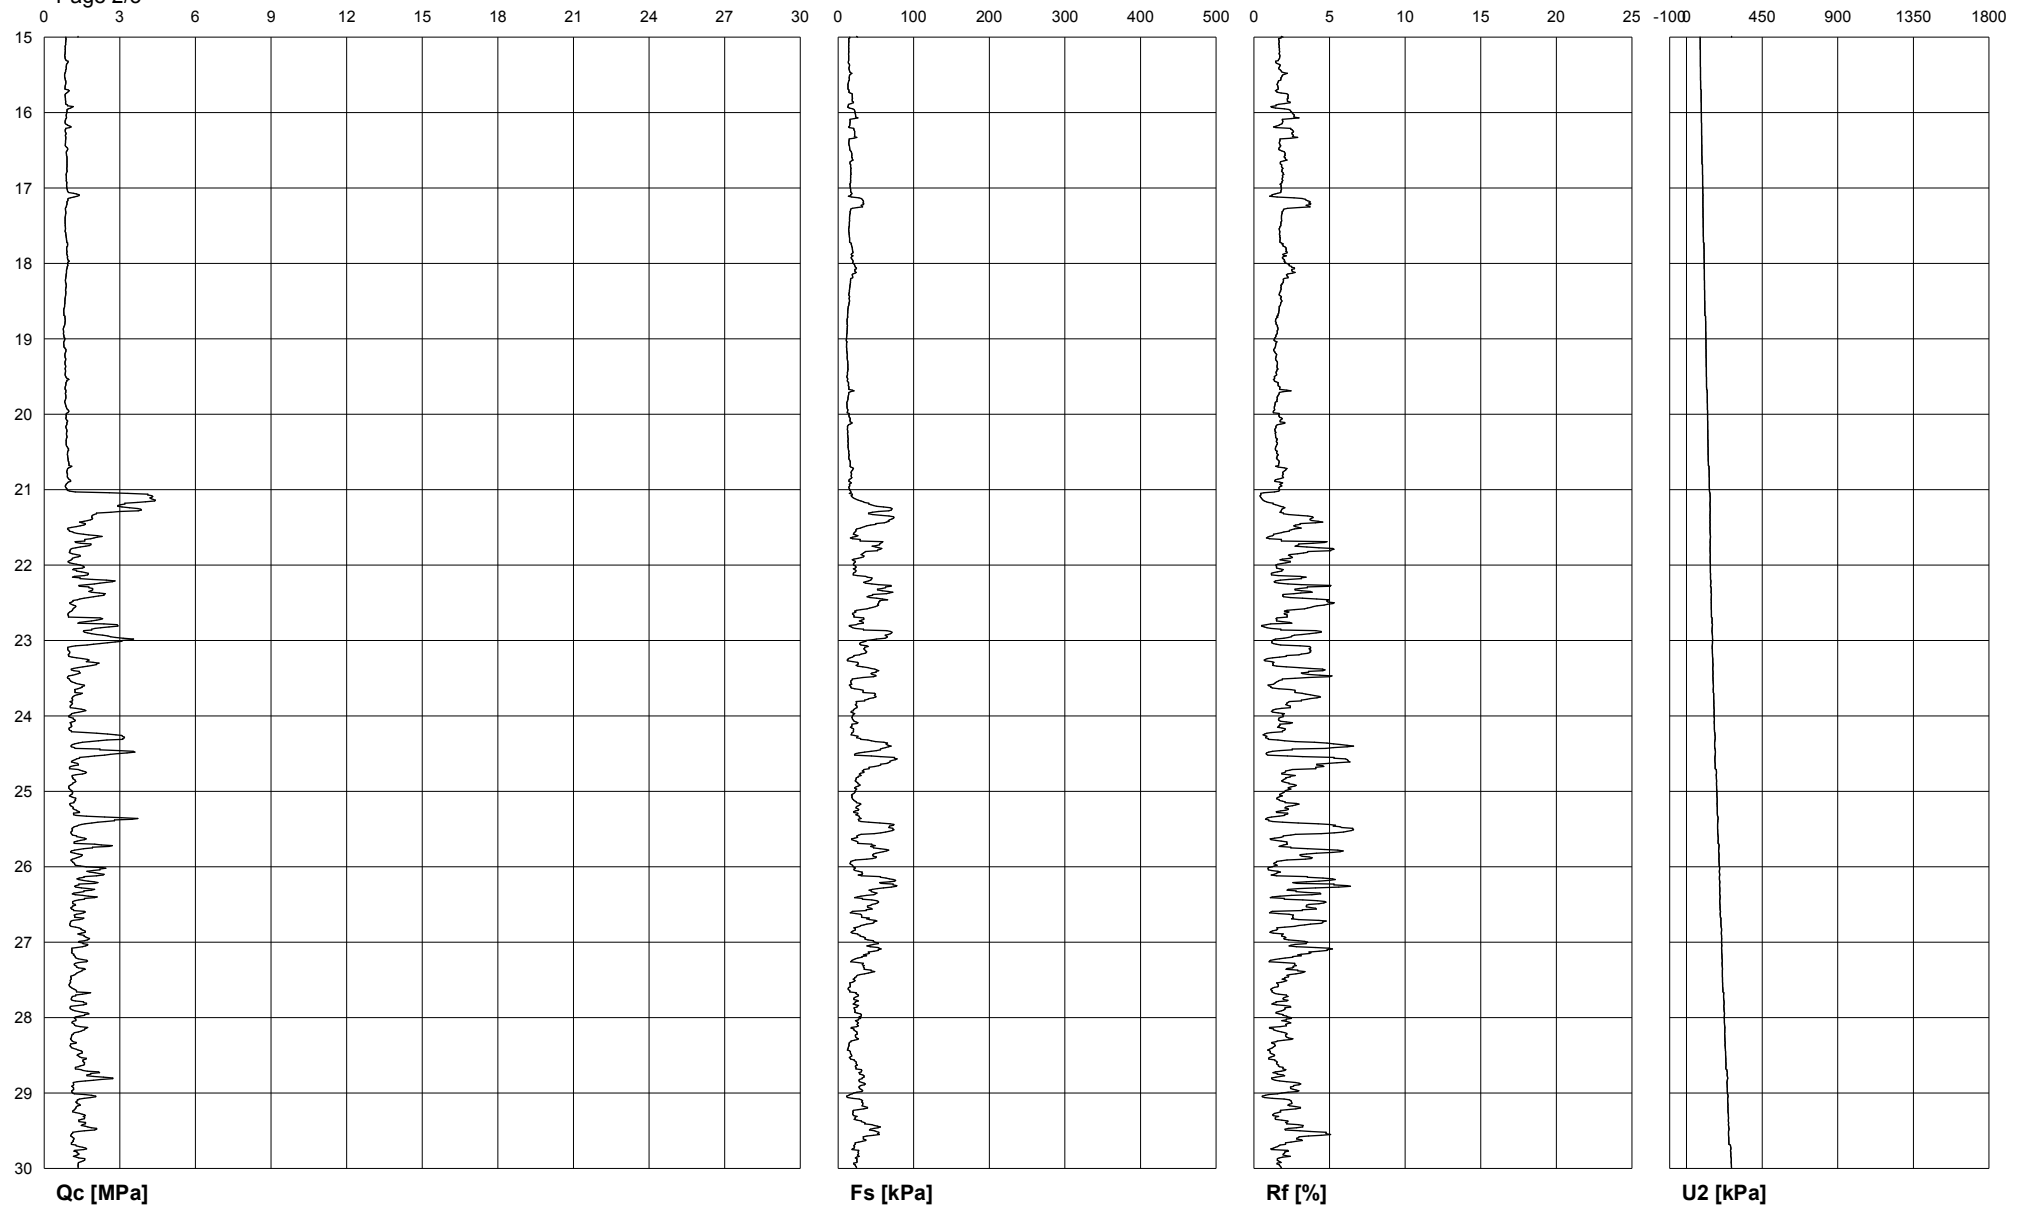
Page 2/3

<b>AS "BMGS"</b>		<b>Commissioner: Piestatnu Nr.2 un Nr.3 rekonstrukcija</b>	
Site: Ventspils brivostas parvalde Locality: Dzintaru iela 51b un 51/3, Ventspils		Test Location: Cpt22 Date: 13.09.2013.	
		Abs. quota [cm]: 230 Prehole [cm]: 220 Hydrostatic Line [cm]: 200

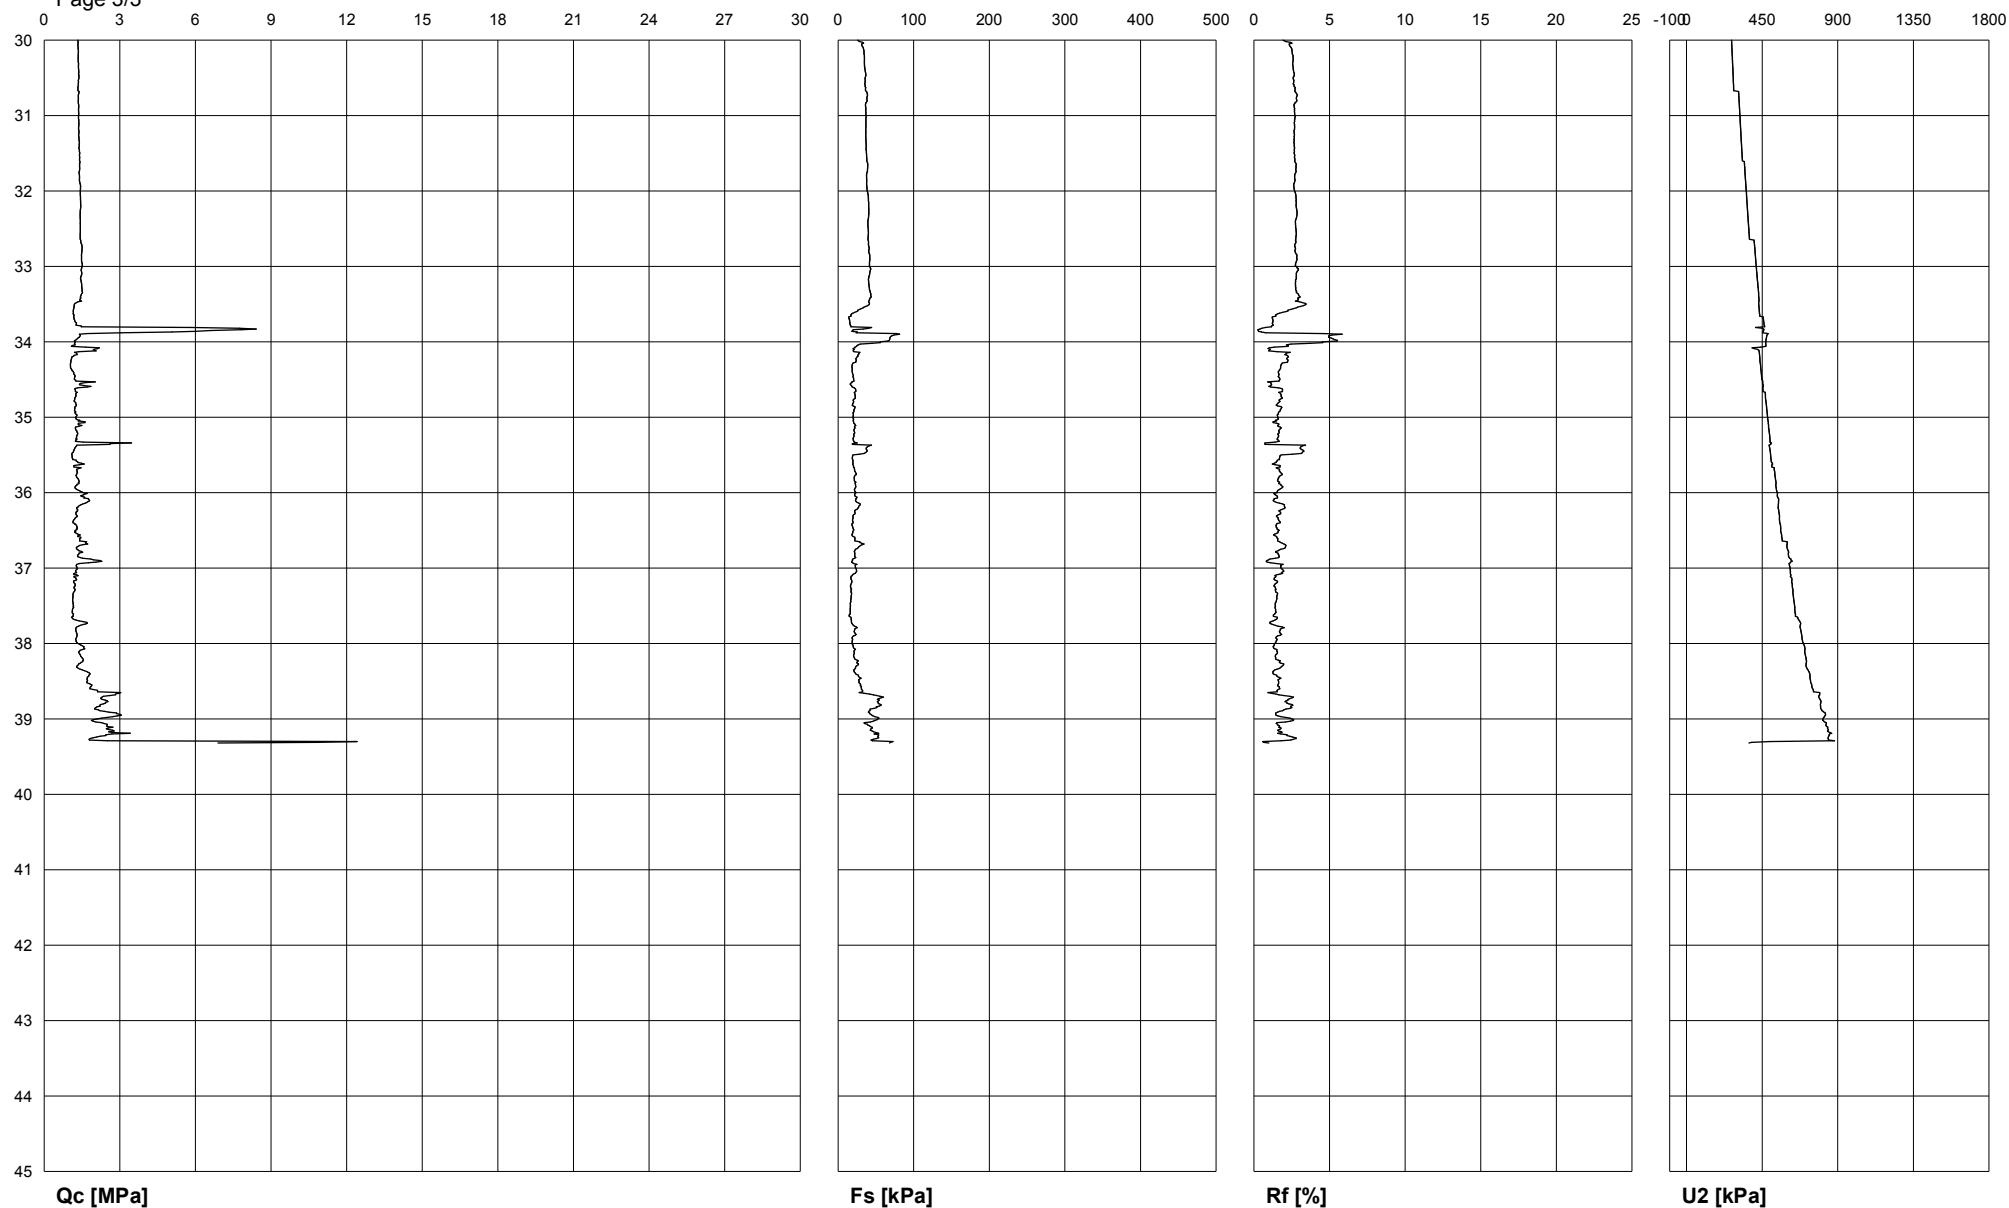
Page 3/3

**AS "BMGS"****Commissioner: Piestatnu Nr.2 un Nr.3 rekonstrukcija**Site: Ventspils brivostas parvalde  
Locality: Dzintaru iela 51b un 51/3, VentspilsTest Location: Cpt22  
Date: 13.09.2013.Abs. quota [cm]: 230  
Prehole [cm]: 220  
Hydrostatic Line [cm]: 200
