AS "BMGS"**Commissioner: Piestatnu Nr.2 un Nr.3 rekonstrukcija**Site: Ventspils brivostas parvalde
Locality: Dzintaru iela 51b un 51/3, VentspilsTest Location: Cpt12
Date: 02.09.2013.Abs. quota [cm]: 220
Prehole [cm]: 230
Hydrostatic Line [cm]: 200

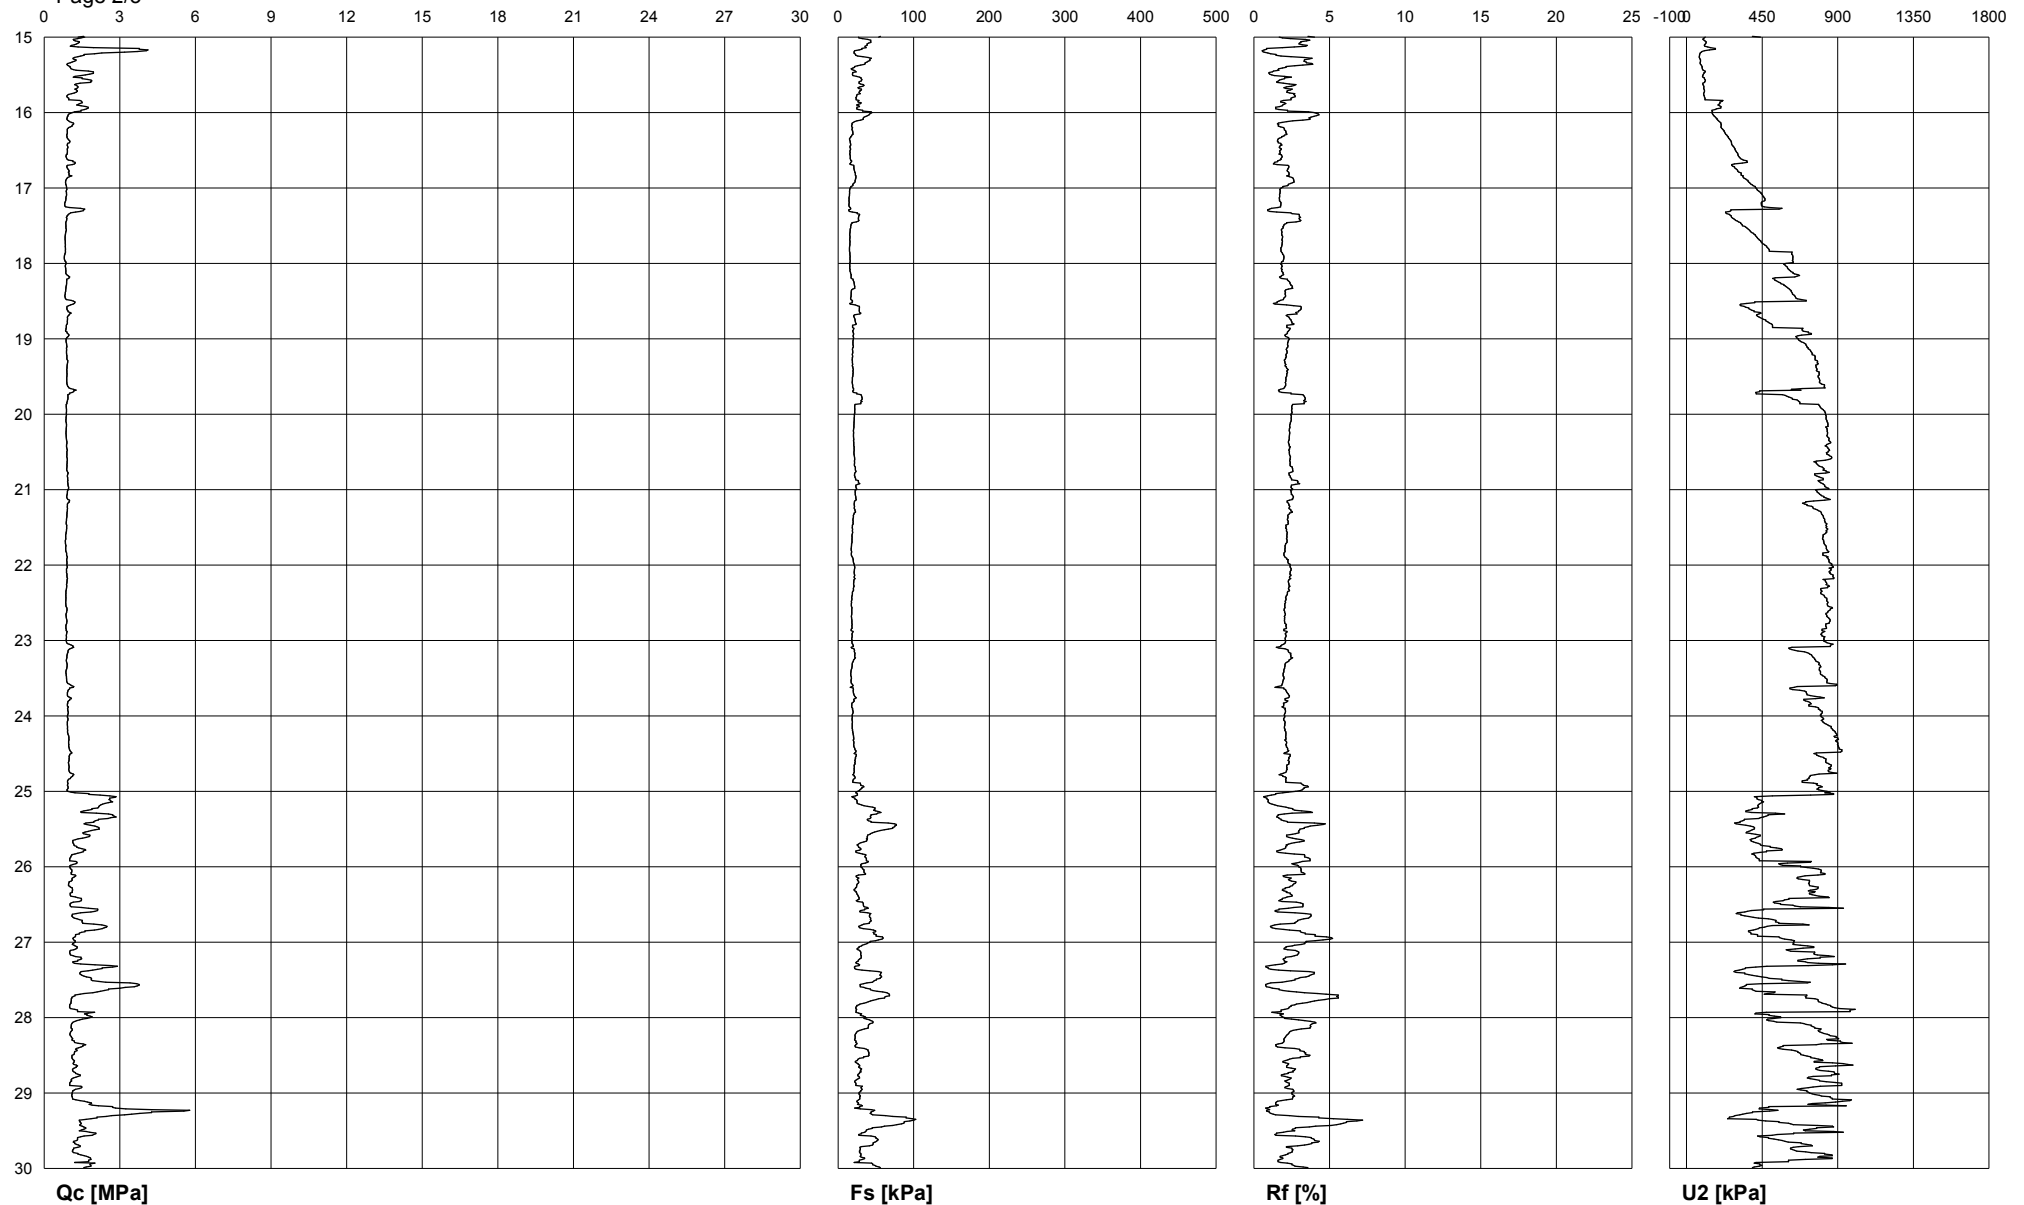
Page 2/3

AS "BMGS"		Commissioner: Piestatnu Nr.2 un Nr.3 rekonstrukcija	
Site: Ventspils brivostas parvalde		Abs. quota [cm]: 220	
Locality: Dzintaru iela 51b un 51/3, Ventspils		Prehole [cm]: 230	
		Hydrostatic Line [cm]: 200	
Test Location: Cpt12			
Date: 02.09.2013.

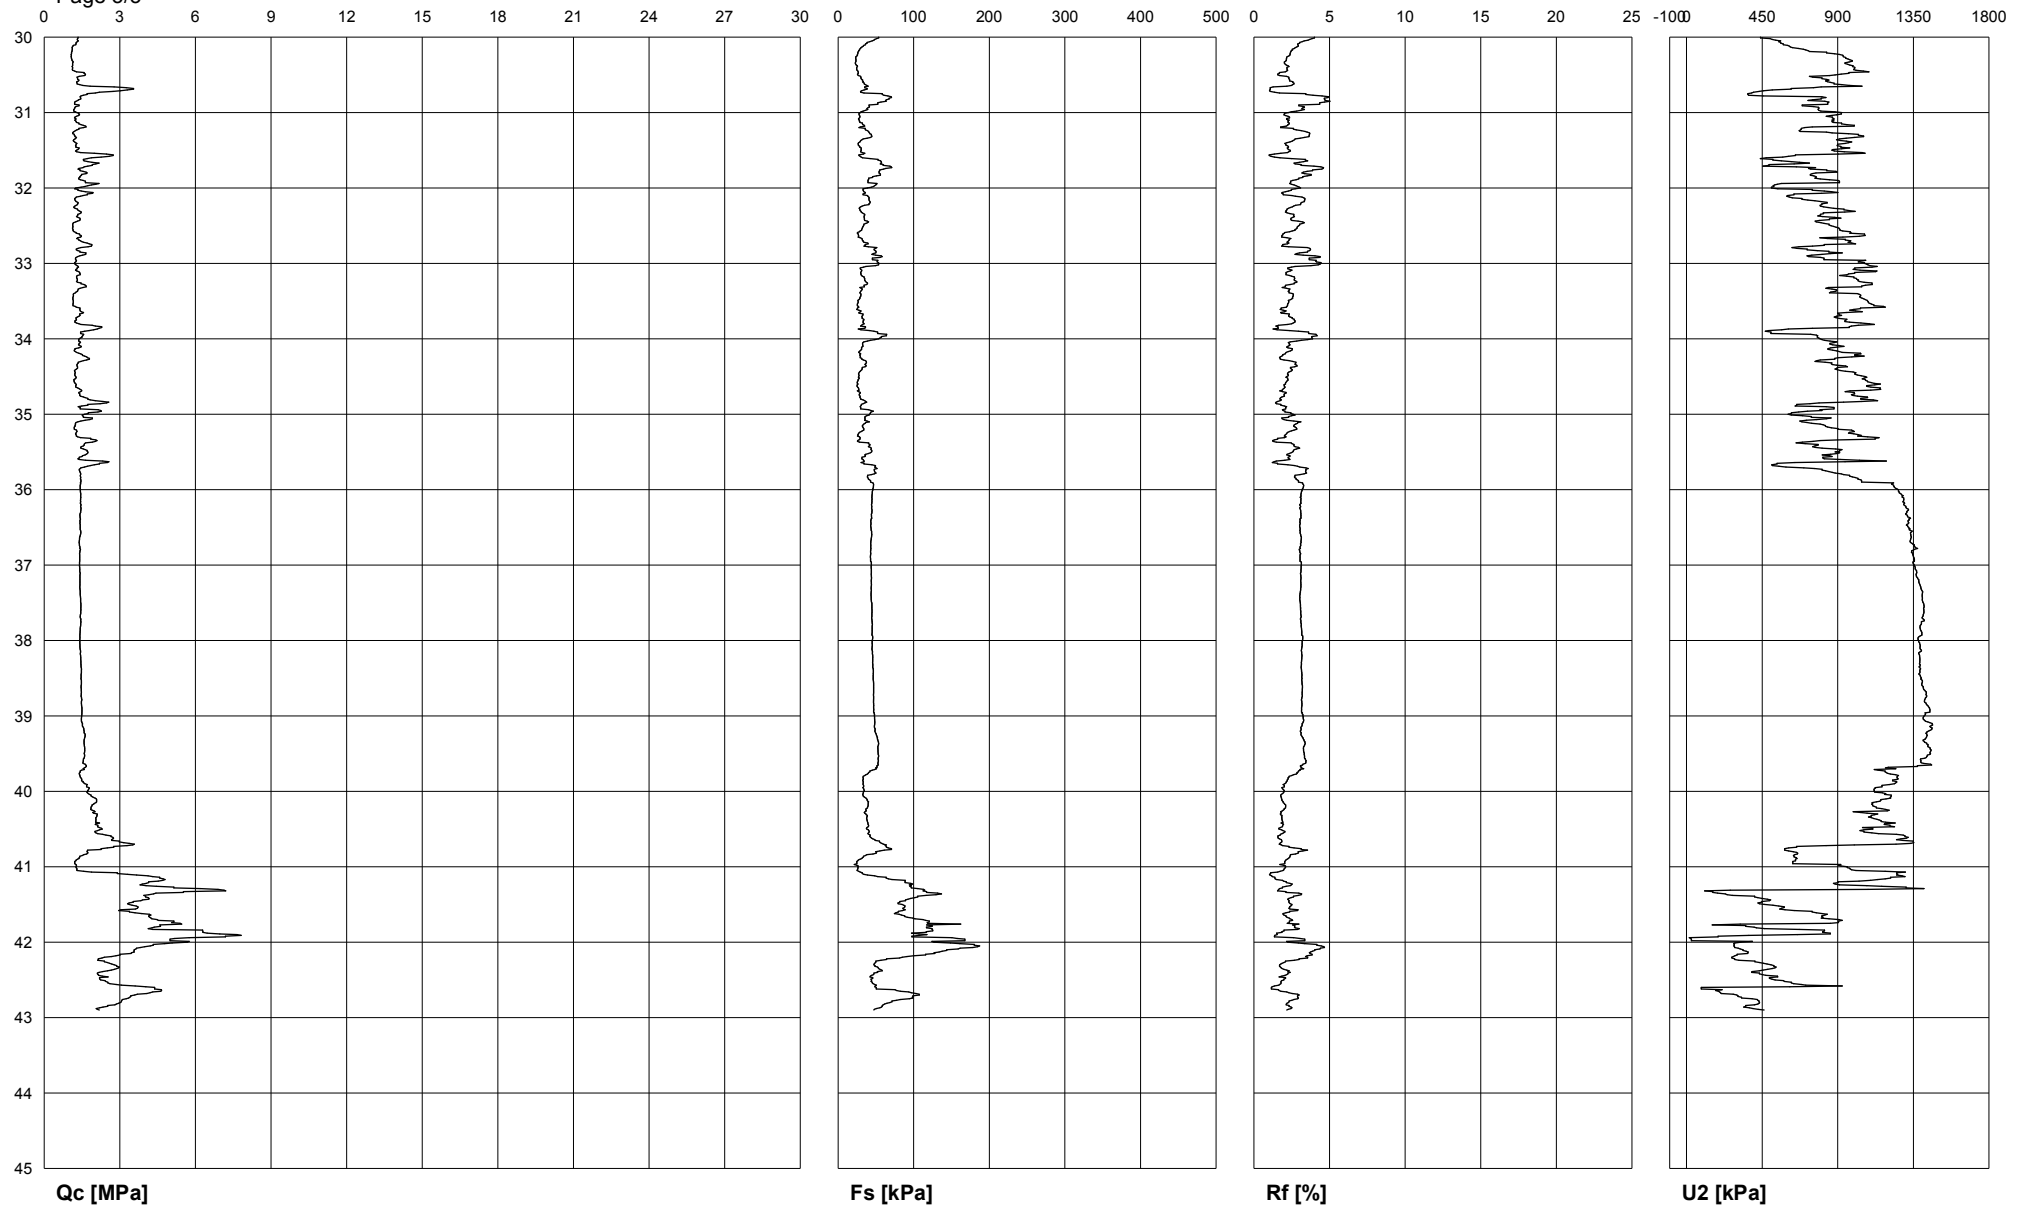
Page 3/3

AS "BMGS"		Commissioner: Piestatnu Nr.2 un Nr.3 rekonstrukcija	
Site: Ventspils brivostas parvalde	Test Location: Cpt12	Abs. quota [cm]: 220	
Locality: Dzintaru iela 51b un 51/3, Ventspils	Date: 02.09.2013.	Prehole [cm]: 230	
		Hydrostatic Line [cm]: 200
