AS "BMGS"**Commissioner: Piestatnu Nr.2 un Nr.3 rekonstrukcija**Site: Ventspils brivostas parvalde
Locality: Dzintaru iela 51b un 51/3, VentspilsTest Location: Cpt15
Date: 05.09.2013.Abs. quota [cm]: 240
Prehole [cm]: 200
Hydrostatic Line [cm]: 200

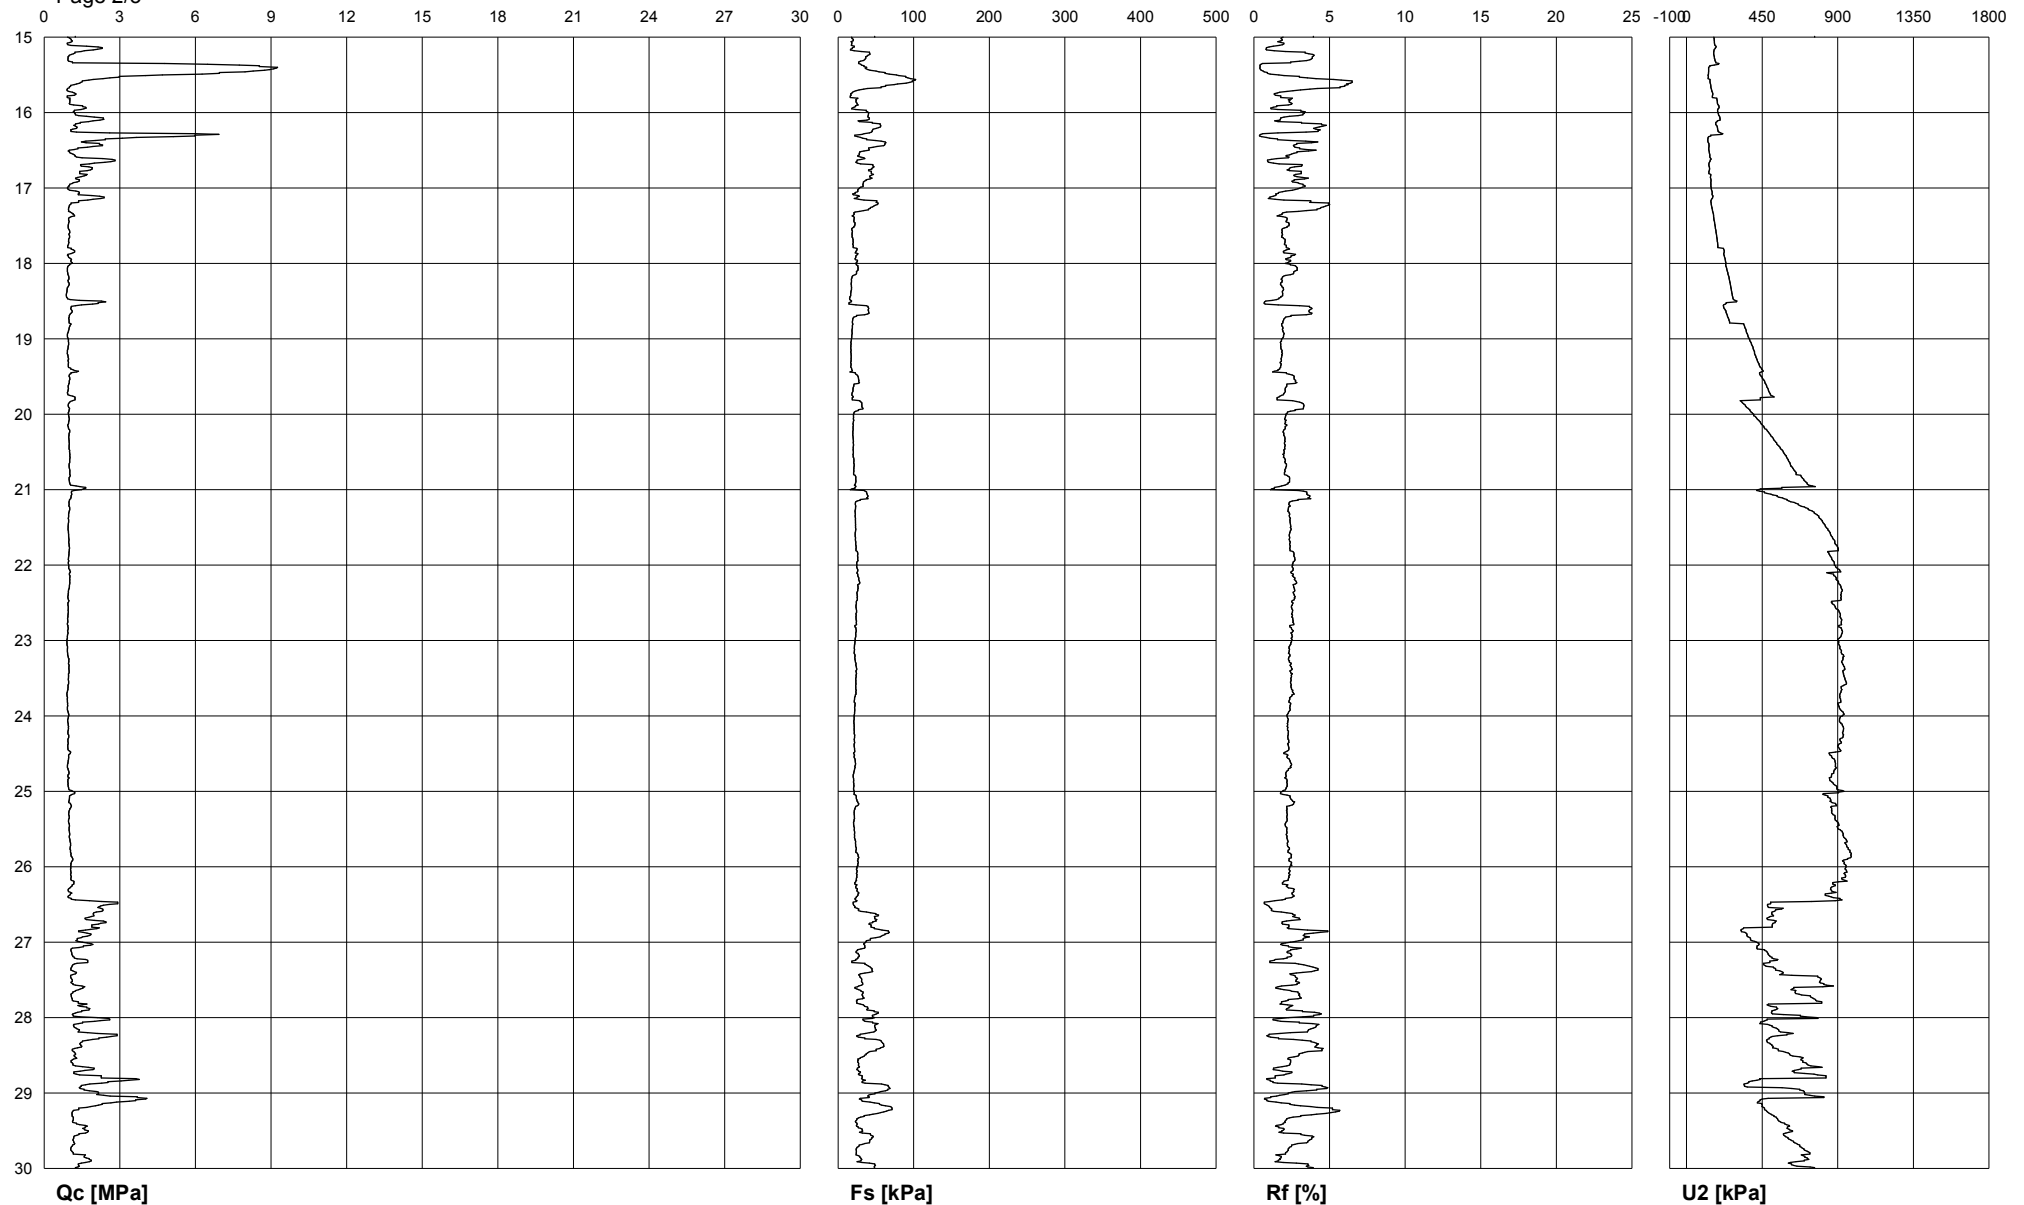
Page 2/3

AS "BMGS"		Commissioner: Piestatnu Nr.2 un Nr.3 rekonstrukcija	
Site: Ventspils brivostas parvalde	Test Location: Cpt15 Date: 05.09.2013.	Abs. quota [cm]: 240	
Locality: Dzintaru iela 51b un 51/3, Ventspils		Prehole [cm]: 200	
		Hydrostatic Line [cm]: 200

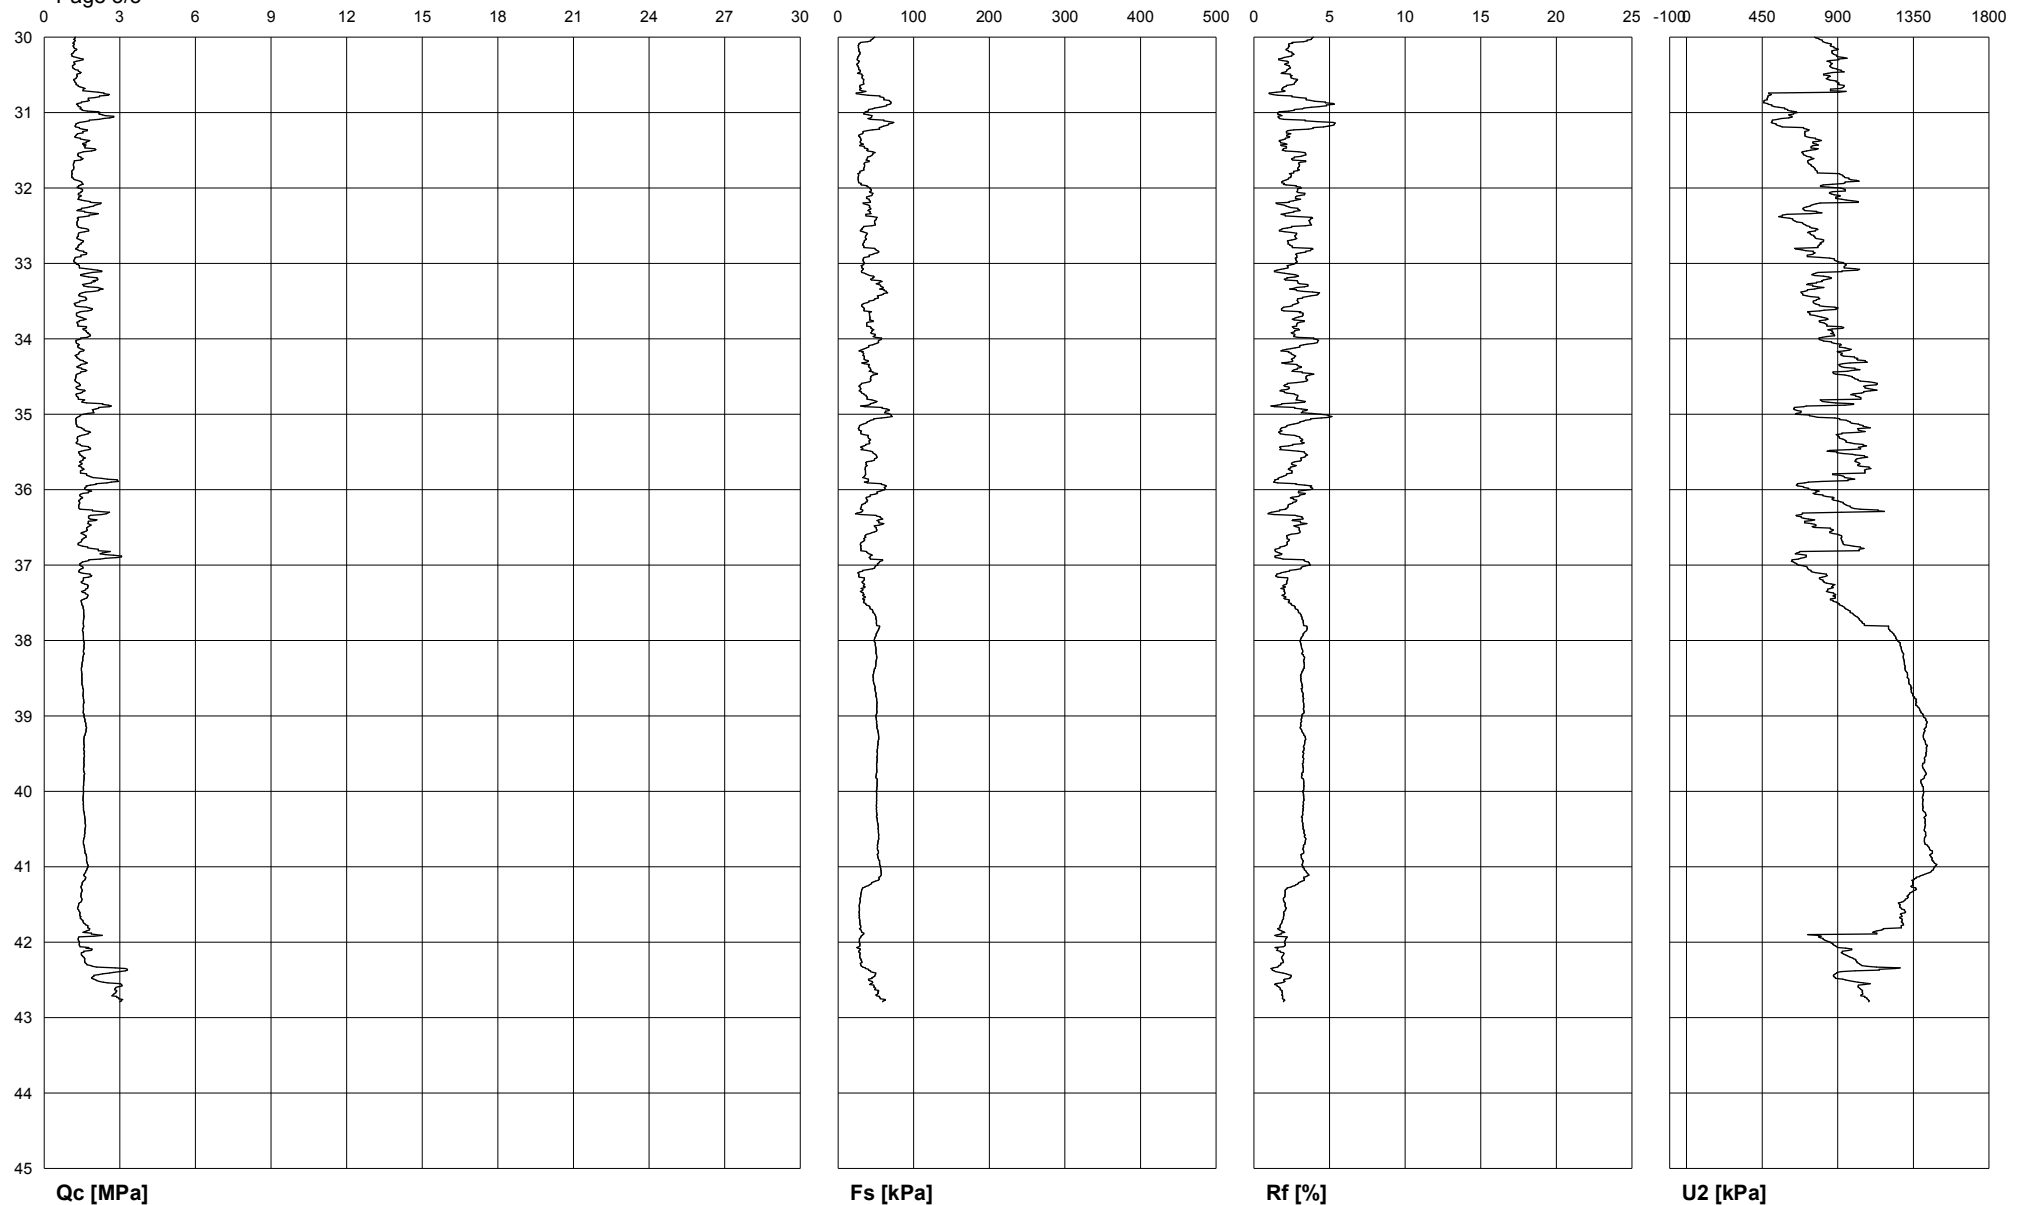
Page 3/3

AS "BMGS"		Commissioner: Piestatnu Nr.2 un Nr.3 rekonstrukcija	
Site: Ventspils brivostas parvalde		Abs. quota [cm]: 240	
Locality: Dzintaru iela 51b un 51/3, Ventspils		Prehole [cm]: 200	
		Hydrostatic Line [cm]: 200	
Test Location: Cpt15			
Date: 05.09.2013.
