**AS "BMGS"****Commissioner: Piestatnu Nr.2 un Nr.3 rekonstrukcija**Site: Ventspils brivostas parvalde  
Locality: Dzintaru iela 51b un 51/3, VentspilsTest Location: Cpt17  
Date: 09.09.2013.Abs. quota [cm]: 230  
Prehole [cm]: 200  
Hydrostatic Line [cm]: 200

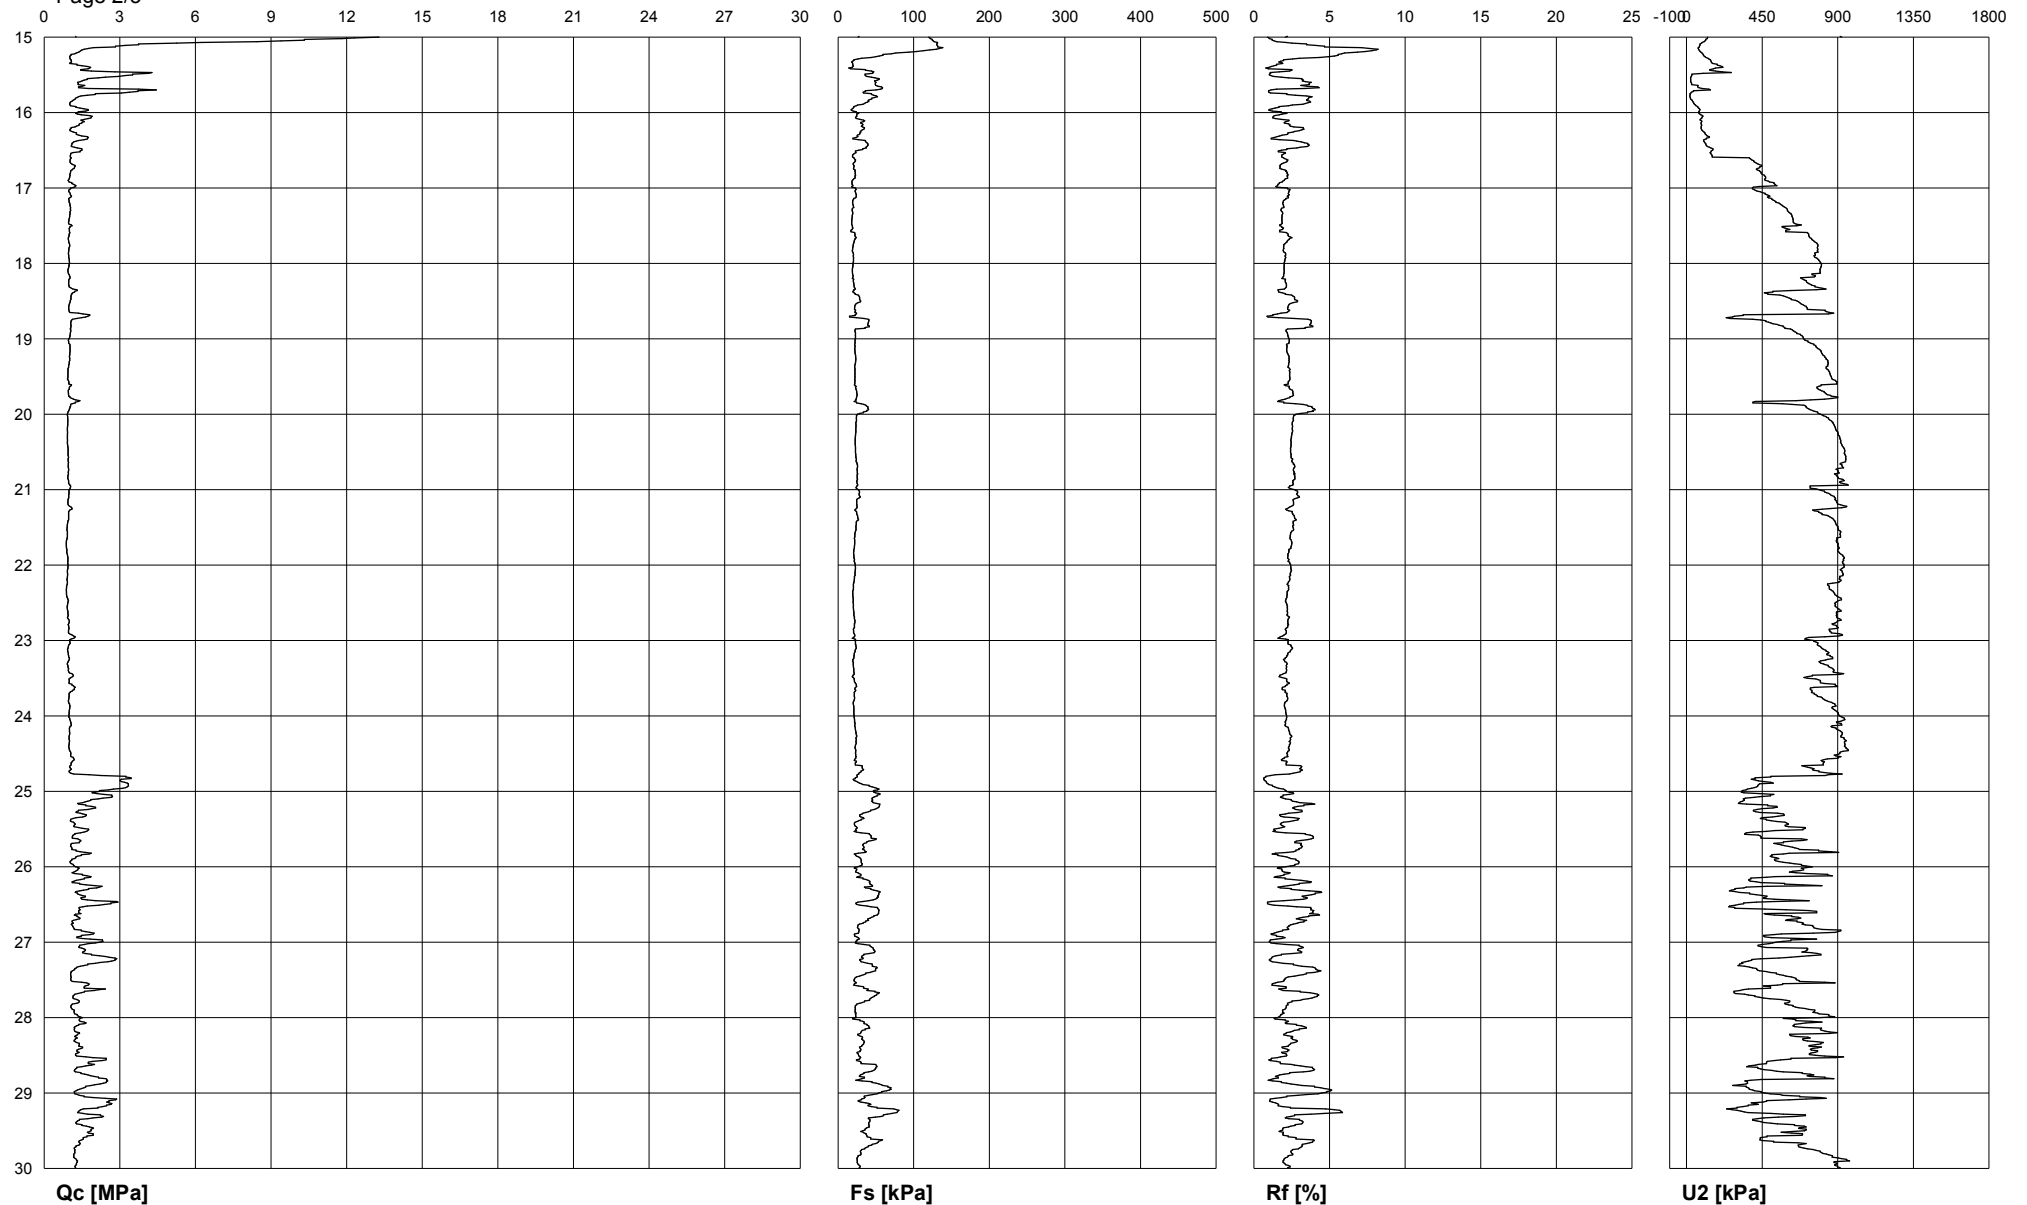
Page 2/3

AS "BMGS"		Commissioner: Piestatnu Nr.2 un Nr.3 rekonstrukcija	
Site: Ventspils brivostas parvalde	Test Location: Cpt17 Date: 09.09.2013.	Abs. quota [cm]: 230	
Locality: Dzintaru iela 51b un 51/3, Ventspils		Prehole [cm]: 200	
		Hydrostatic Line [cm]: 200

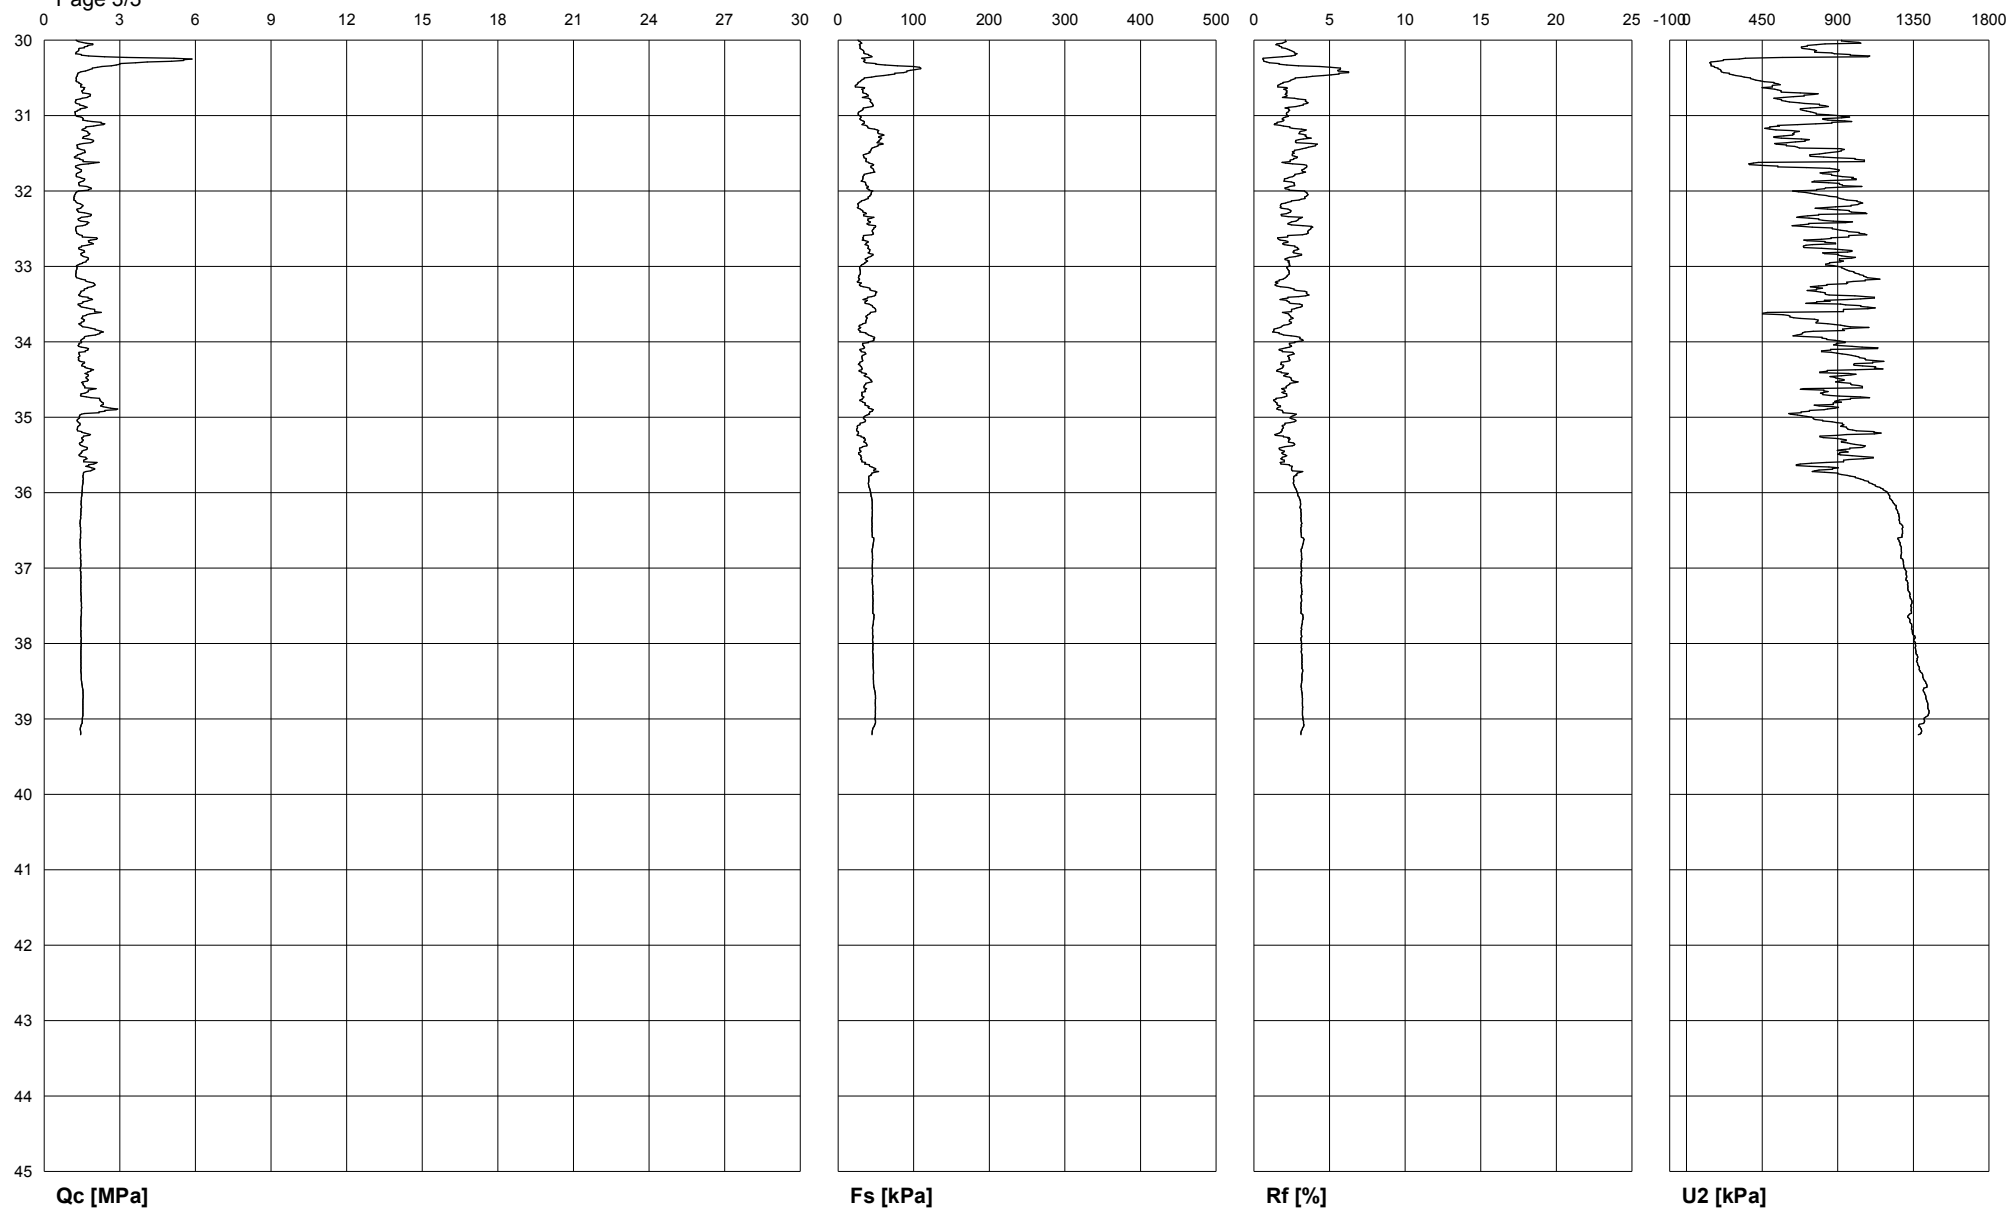
Page 3/3

**AS "BMGS"****Commissioner: Piestatnu Nr.2 un Nr.3 rekonstrukcija**Site: Ventspils brivostas parvalde  
Locality: Dzintaru iela 51b un 51/3, VentspilsTest Location: Cpt17  
Date: 09.09.2013.Abs. quota [cm]: 230  
Prehole [cm]: 200  
Hydrostatic Line [cm]: 200

**Qc [MPa]****Fs [kPa]****Rf [%]****U2 [kPa]**
