AS "BMGS"**Commissioner: Piestatnu Nr.2 un Nr.3 rekonstrukcija**Site: Ventspils brivostas parvalde
Locality: Dzintaru iela 51b un 51/3, VentspilsTest Location: Cpt18
Date: 10.09.2013.Abs. quota [cm]: 250
Prehole [cm]: 220
Hydrostatic Line [cm]: 220

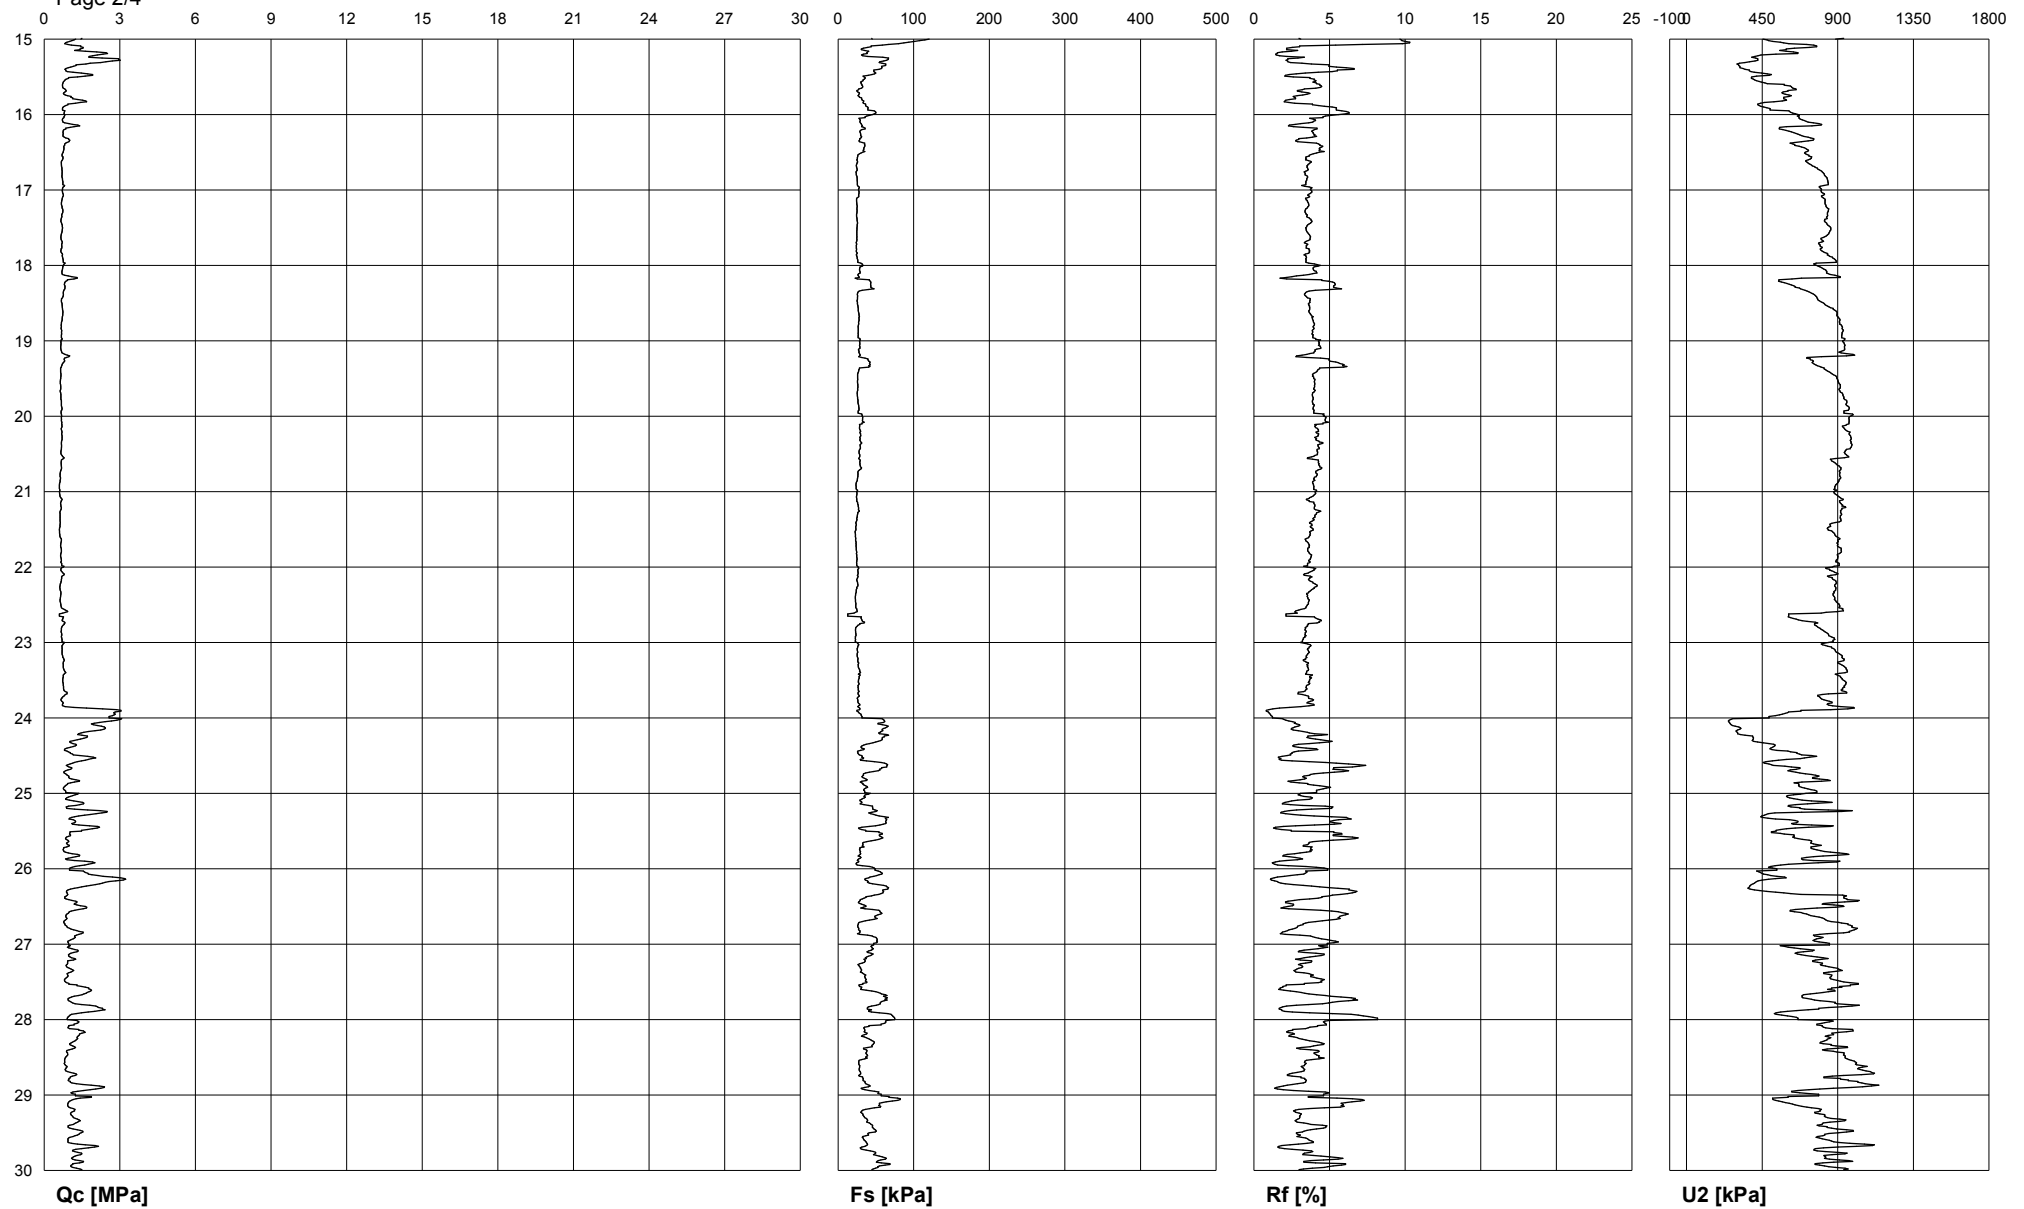
Page 2/4

AS "BMGS"		Commissioner: Piestatnu Nr.2 un Nr.3 rekonstrukcija	
Site: Ventspils brivostas parvalde	Test Location: Cpt18	Abs. quota [cm]: 250	
Locality: Dzintaru iela 51b un 51/3, Ventspils		Prehole [cm]: 220	
		Hydrostatic Line [cm]: 220

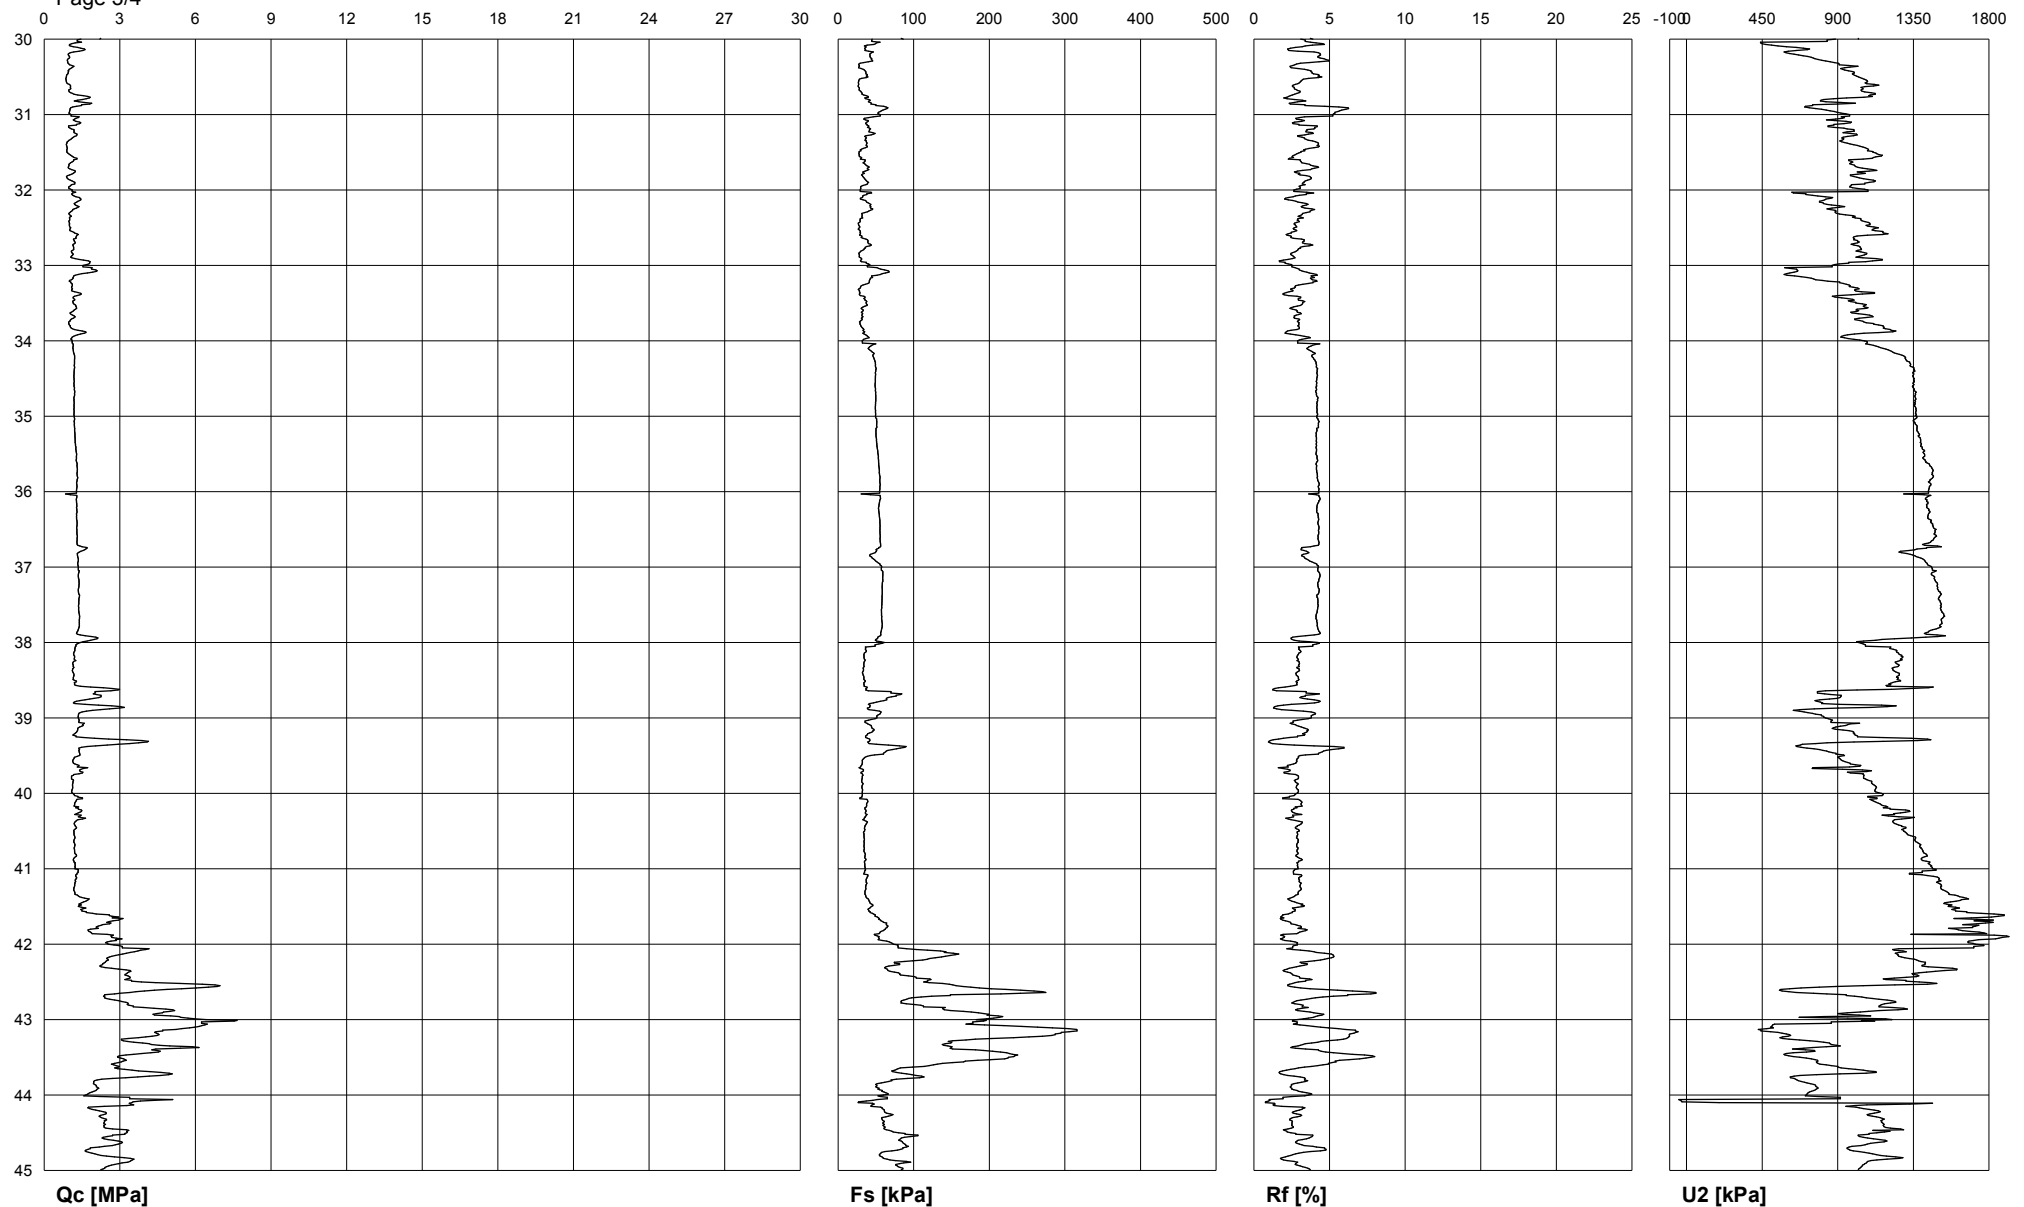
Page 3/4

AS "BMGS"		Commissioner: Piestatnu Nr.2 un Nr.3 rekonstrukcija	
Site: Ventspils brivostas parvalde	Test Location: Cpt18	Abs. quota [cm]: 250	
Locality: Dzintaru iela 51b un 51/3, Ventspils	Date: 10.09.2013.	Prehole [cm]: 220	
		Hydrostatic Line [cm]: 220

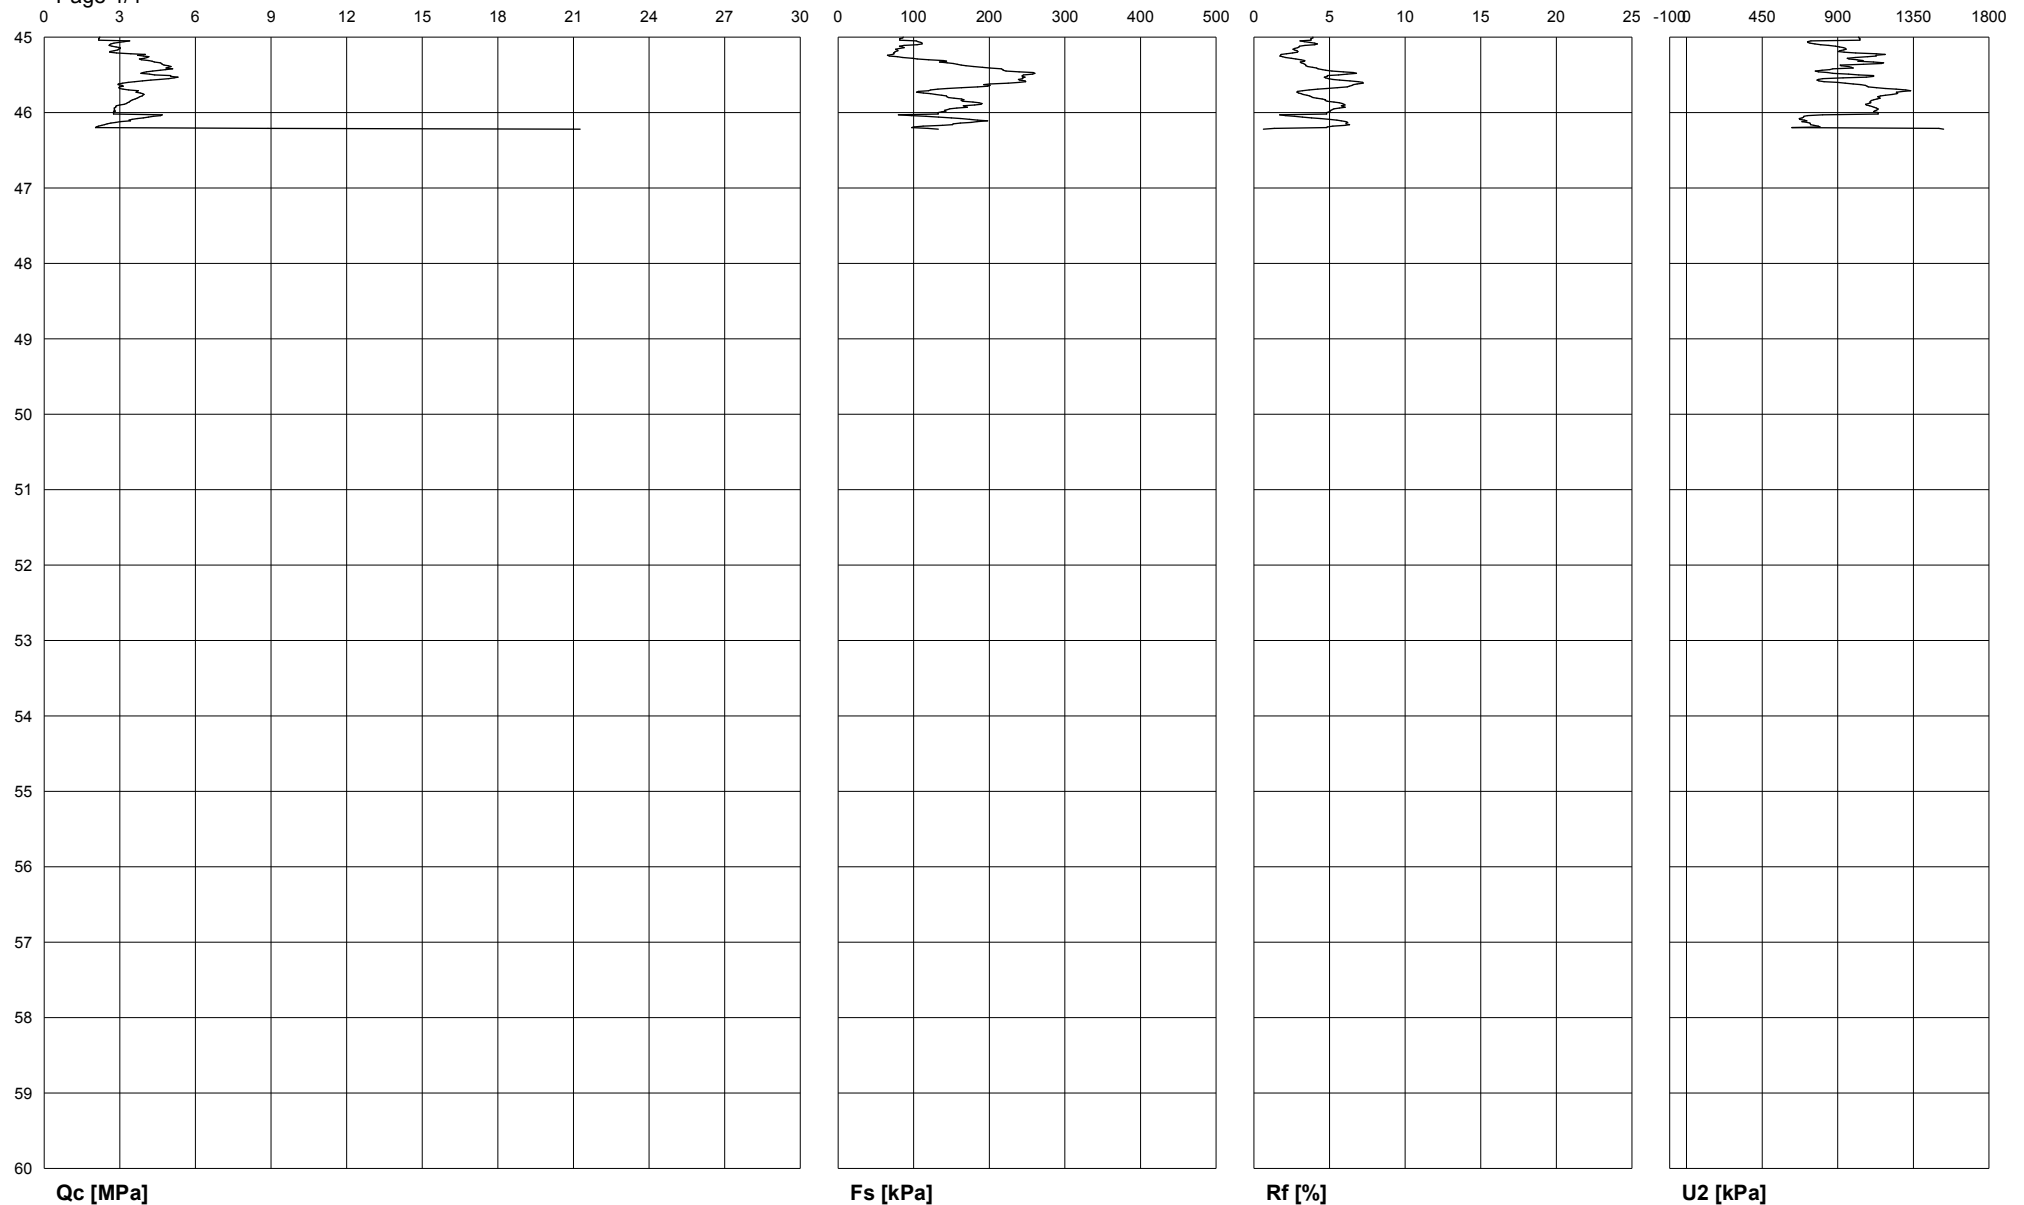
Page 4/4

AS "BMGS"		Commissioner: Piestatnu Nr.2 un Nr.3 rekonstrukcija	
Site: Ventspils brivostas parvalde Locality: Dzintaru iela 51b un 51/3, Ventspils		Test Location: Cpt18 Date: 2013.08.29.	
		Abs. quota [cm]: 250 Prehole [cm]: 220 Hydrostatic Line [cm]: 220
