AS "BMGS"**Commissioner: Piestatnu Nr.2 un Nr.3 rekonstrukcija**Site: Ventspils brivostas parvalde
Locality: Dzintaru iela 51b un 51/3, VentspilsTest Location: Cpt19
Date: 11.09.2013.Abs. quota [cm]: 230
Prehole [cm]: 250
Hydrostatic Line [cm]: 210

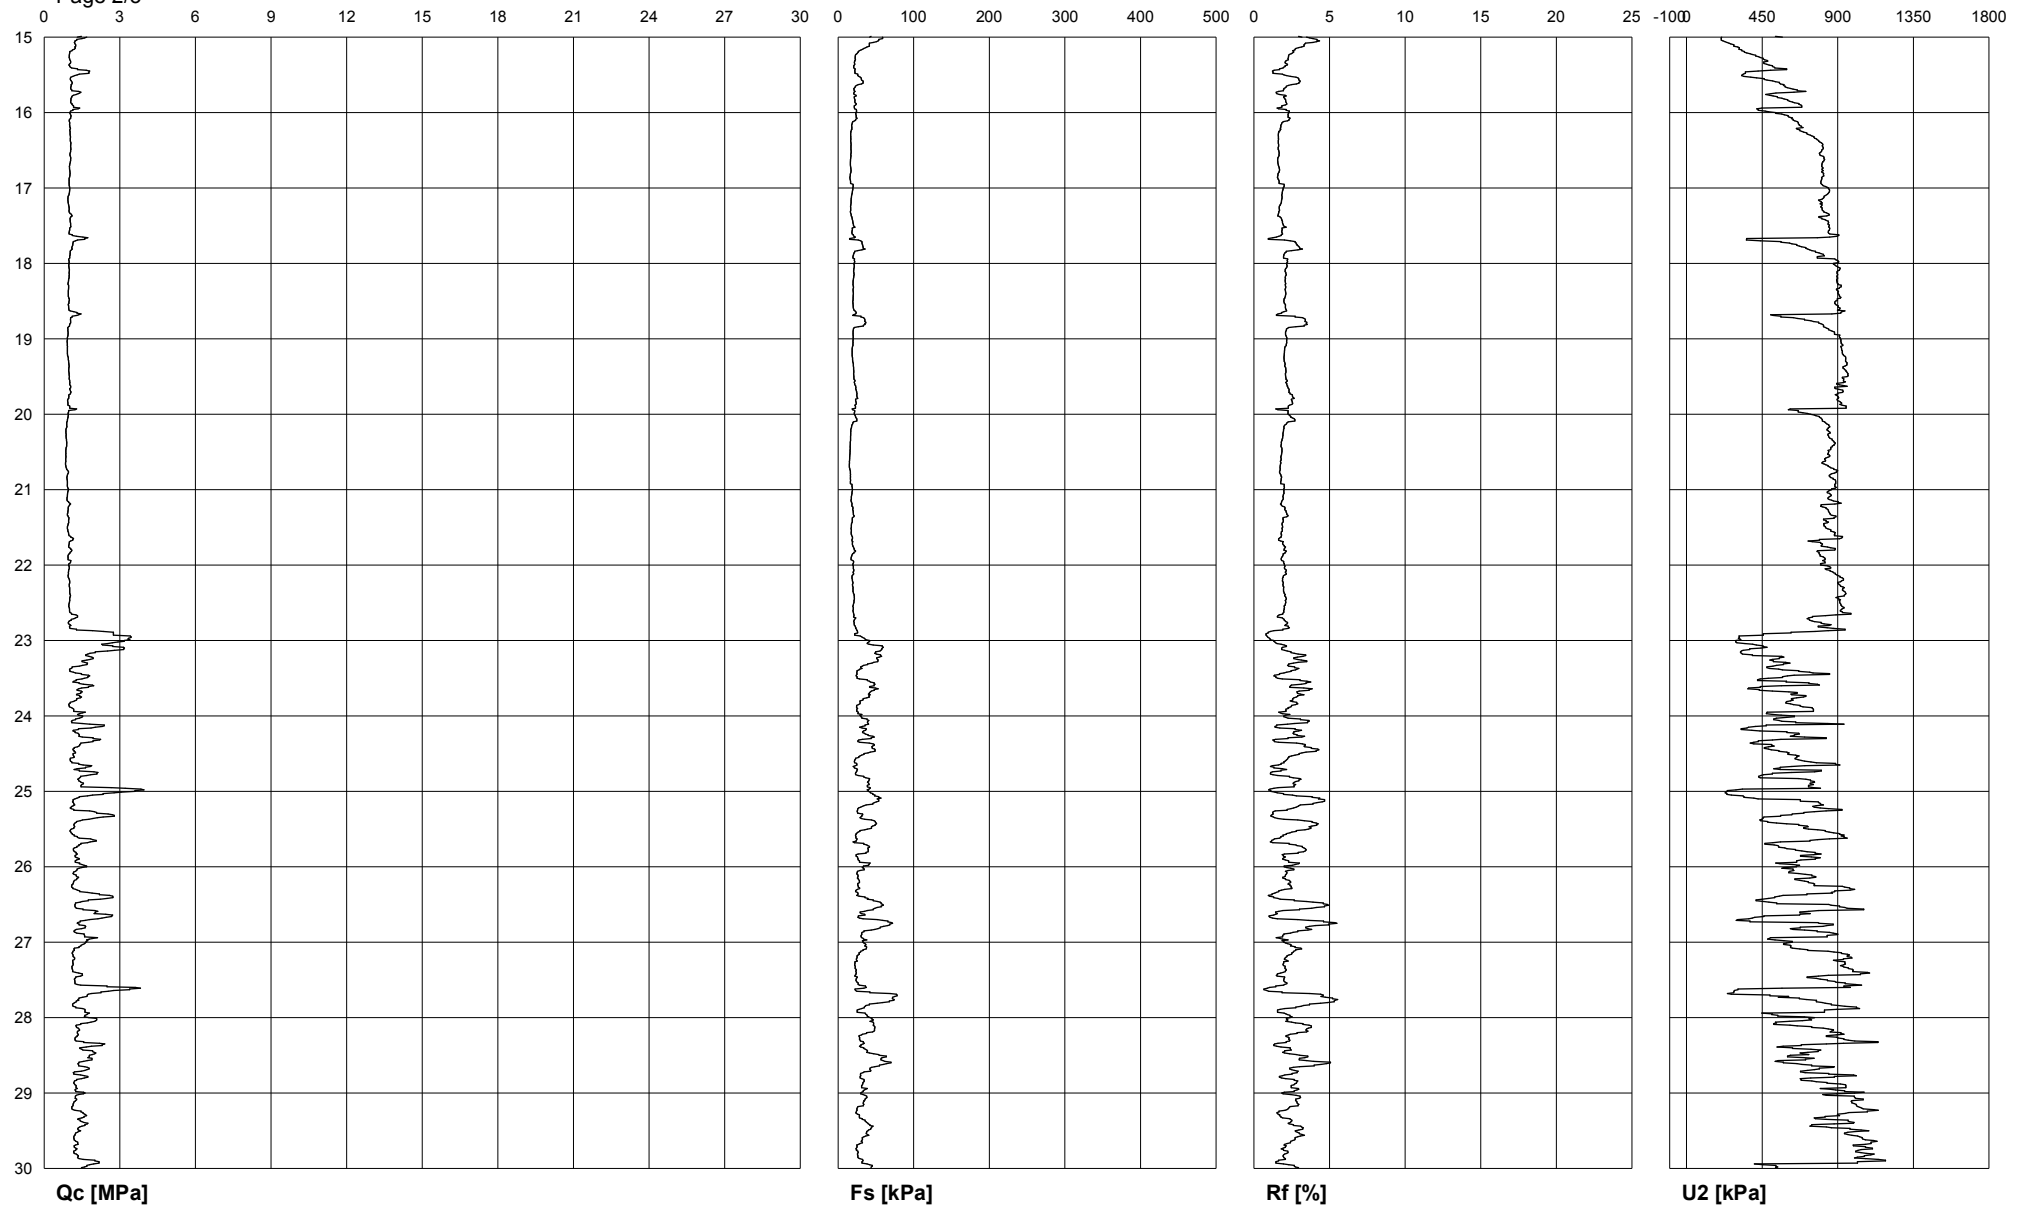
Page 2/3

AS "BMGS"		Commissioner: Piestatnu Nr.2 un Nr.3 rekonstrukcija	
Site: Ventspils brivostas parvalde		Abs. quota [cm]: 230	
Locality: Dzintaru iela 51b un 51/3, Ventspils		Prehole [cm]: 250	
		Hydrostatic Line [cm]: 210	
Test Location: Cpt19			
Date: 11.09.2013.

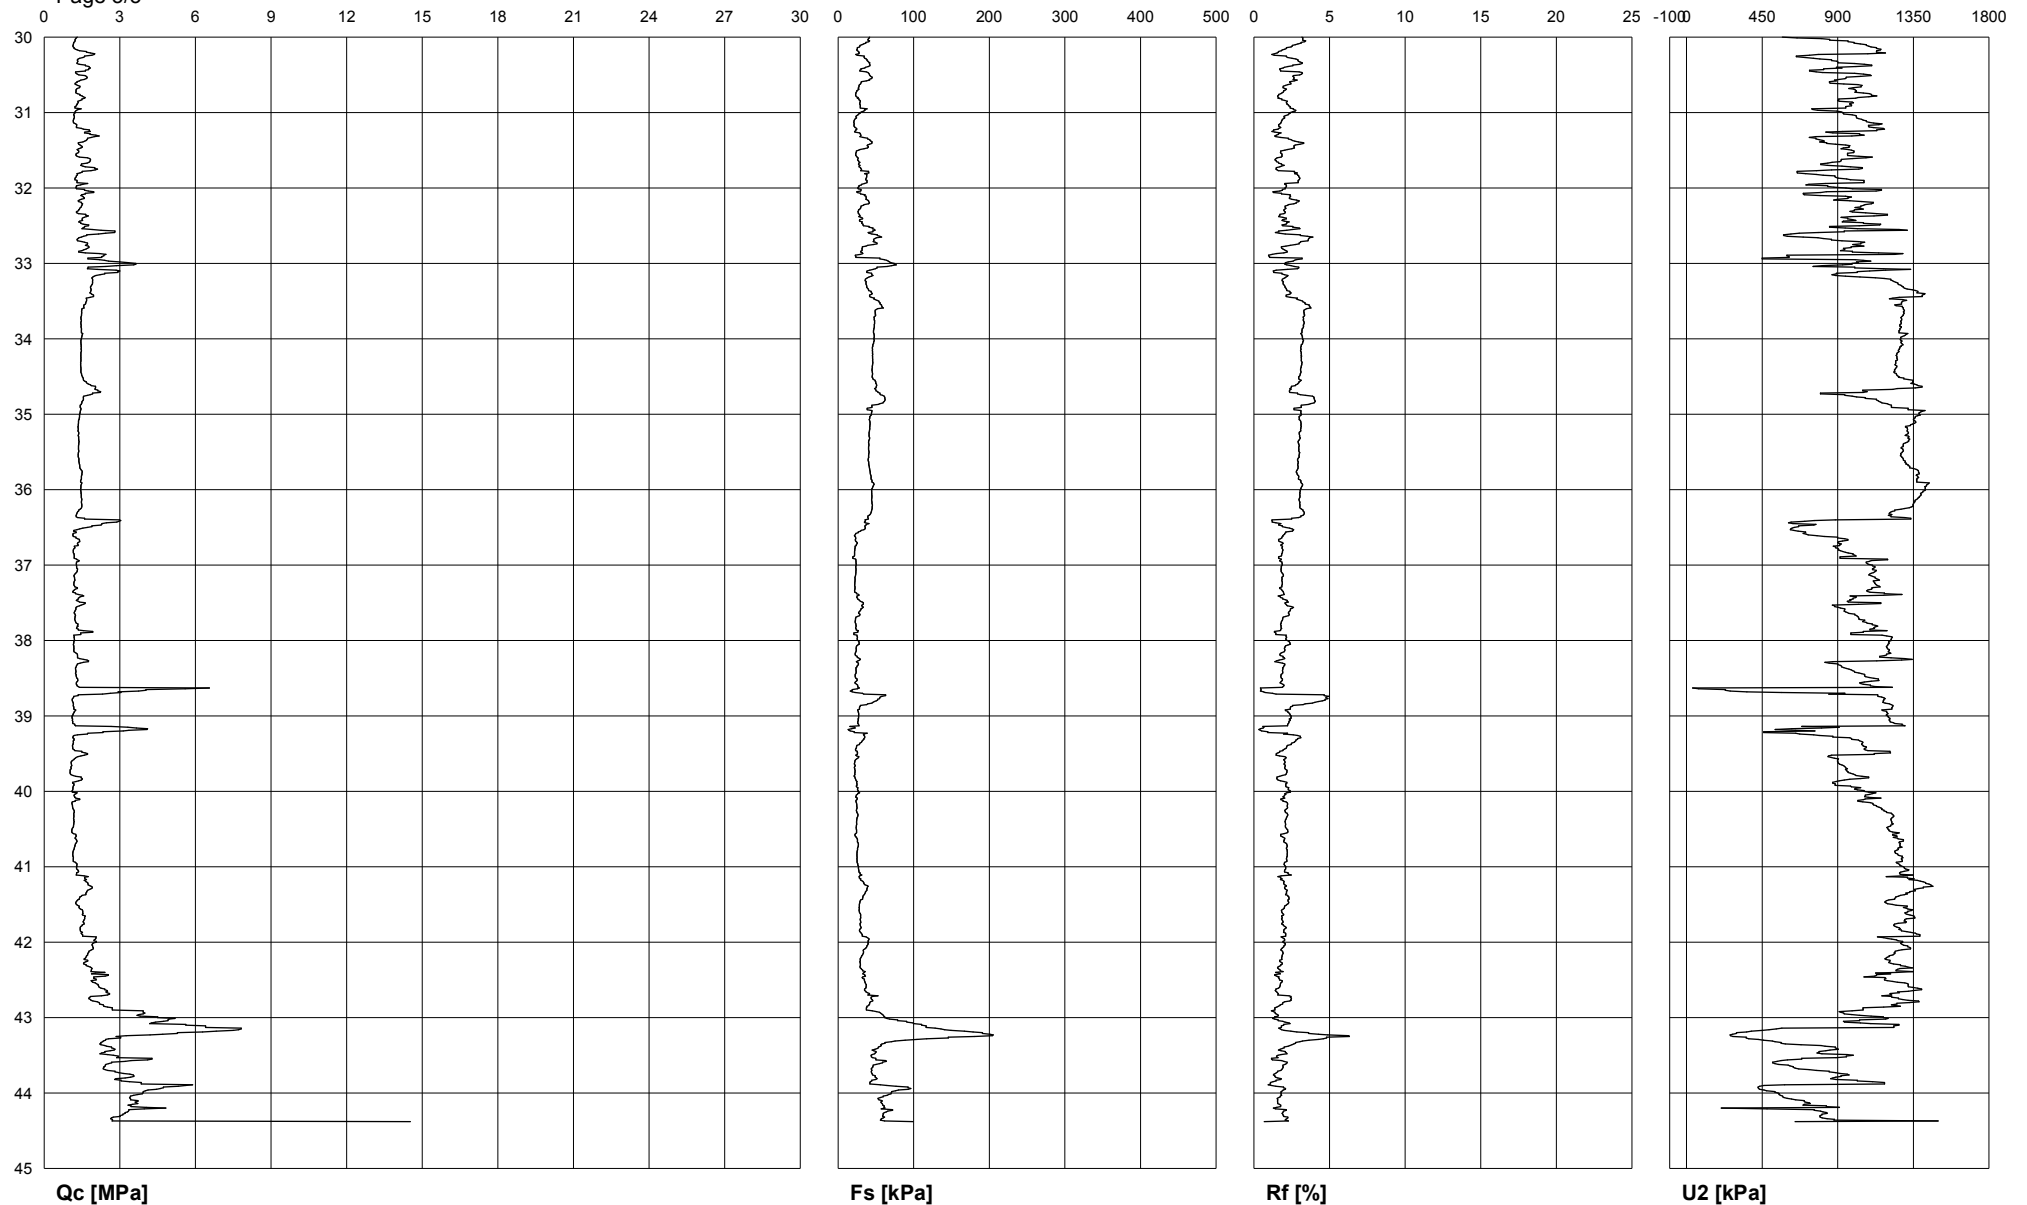
Page 3/3

AS "BMGS"		Commissioner: Piestatnu Nr.2 un Nr.3 rekonstrukcija	
Site: Ventspils brivostas parvalde	Test Location: Cpt19 Date: 11.09.2013.	Abs. quota [cm]: 230	
Locality: Dzintaru iela 51b un 51/3, Ventspils		Prehole [cm]: 250	
		Hydrostatic Line [cm]: 210
