AS "BMGS"**Commissioner: Piestatnu Nr.2 un Nr.3 rekonstrukcija**Site: Ventspils brivostas parvalde
Locality: Dzintaru iela 51b un 51/3, VentspilsTest Location: Cpt21
Date: 12.09.2013.Abs. quota [cm]: 230
Prehole [cm]: 250
Hydrostatic Line [cm]: 210

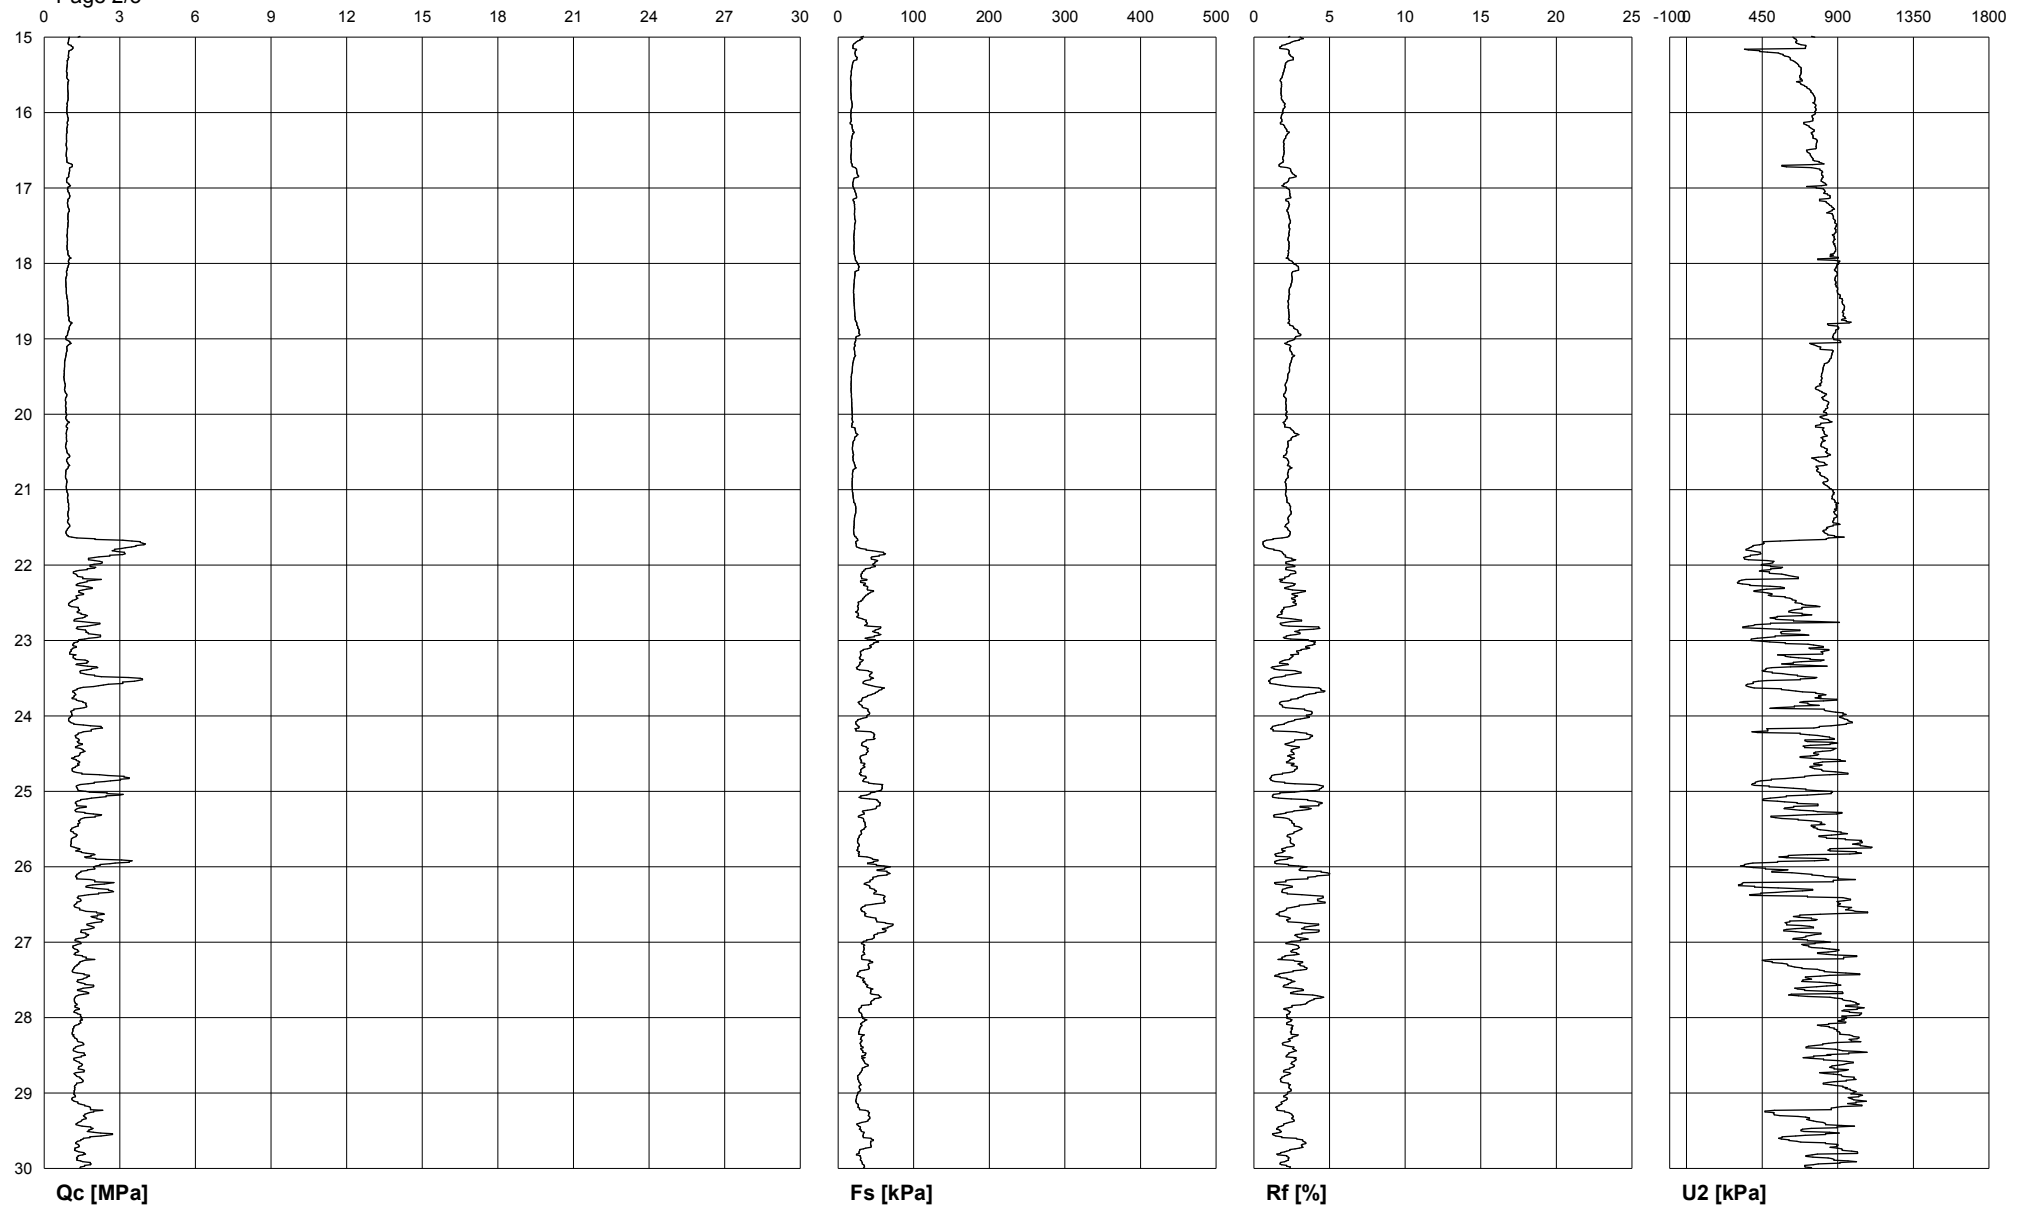
Page 2/3

AS "BMGS"		Commissioner: Piestatnu Nr.2 un Nr.3 rekonstrukcija	
Site: Ventspils brivostas parvalde Locality: Dzintaru iela 51b un 51/3, Ventspils		Test Location: Cpt21 Date: 12.09.2013.	
		Abs. quota [cm]: 230 Prehole [cm]: 250 Hydrostatic Line [cm]: 210

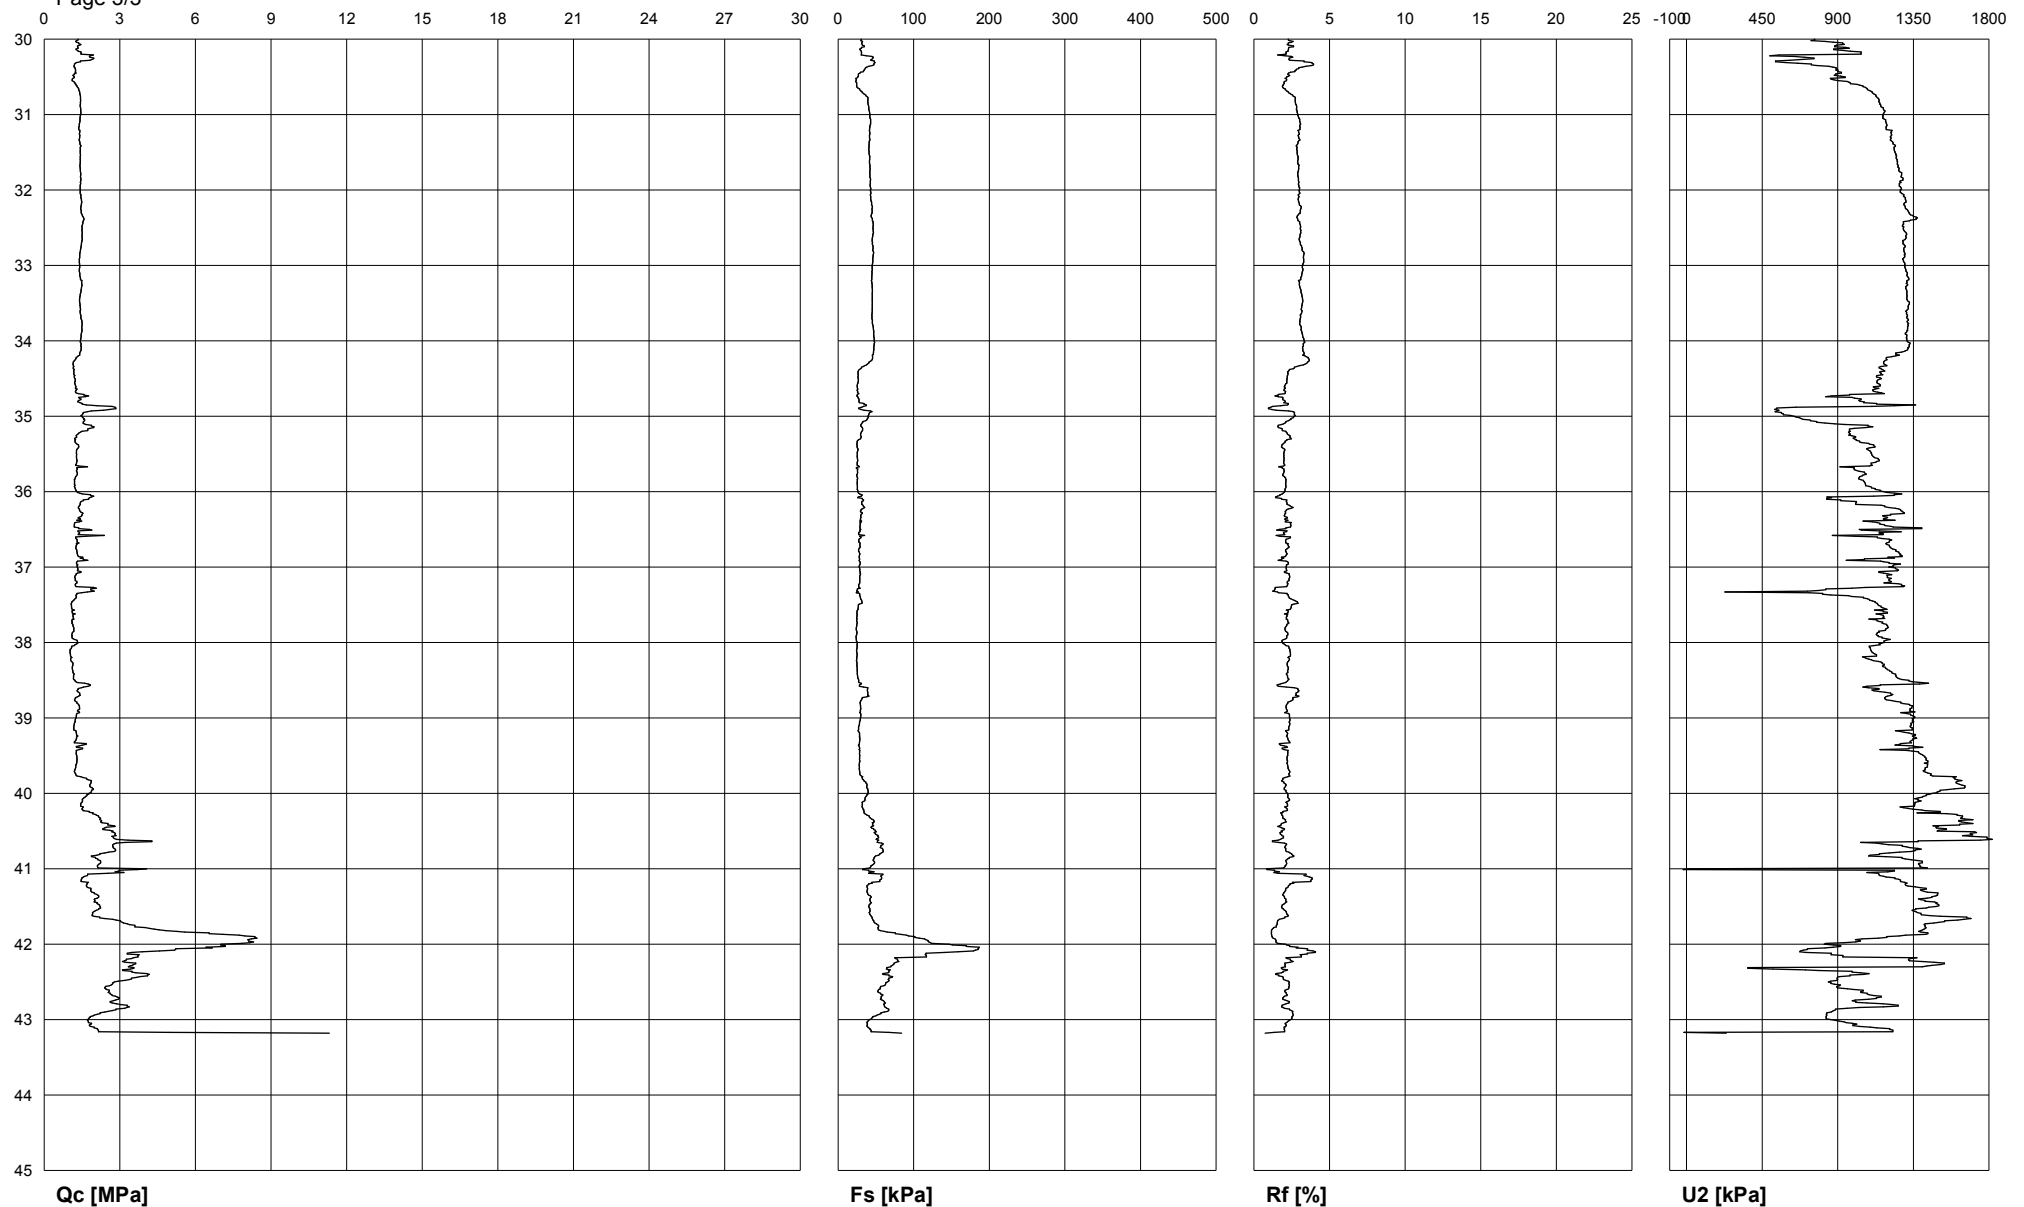
Page 3/3

AS "BMGS"		Commissioner: Piestatnu Nr.2 un Nr.3 rekonstrukcija	
Site: Ventspils brivostas parvalde Locality: Dzintaru iela 51b un 51/3, Ventspils		Test Location: Cpt21 Date: 12.09.2013.	Abs. quota [cm]: 230 Prehole [cm]: 250 Hydrostatic Line [cm]: 210
