**AS "BMGS"****Commissioner: Piestatnu Nr.2 un Nr.3 rekonstrukcija**Site: Ventspils brivostas parvalde  
Locality: Dzintaru iela 51b un 51/3, VentspilsTest Location: Cpt13  
Date: 03.09.2013.Abs. quota [cm]: 250  
Prehole [cm]: 200  
Hydrostatic Line [cm]: 230

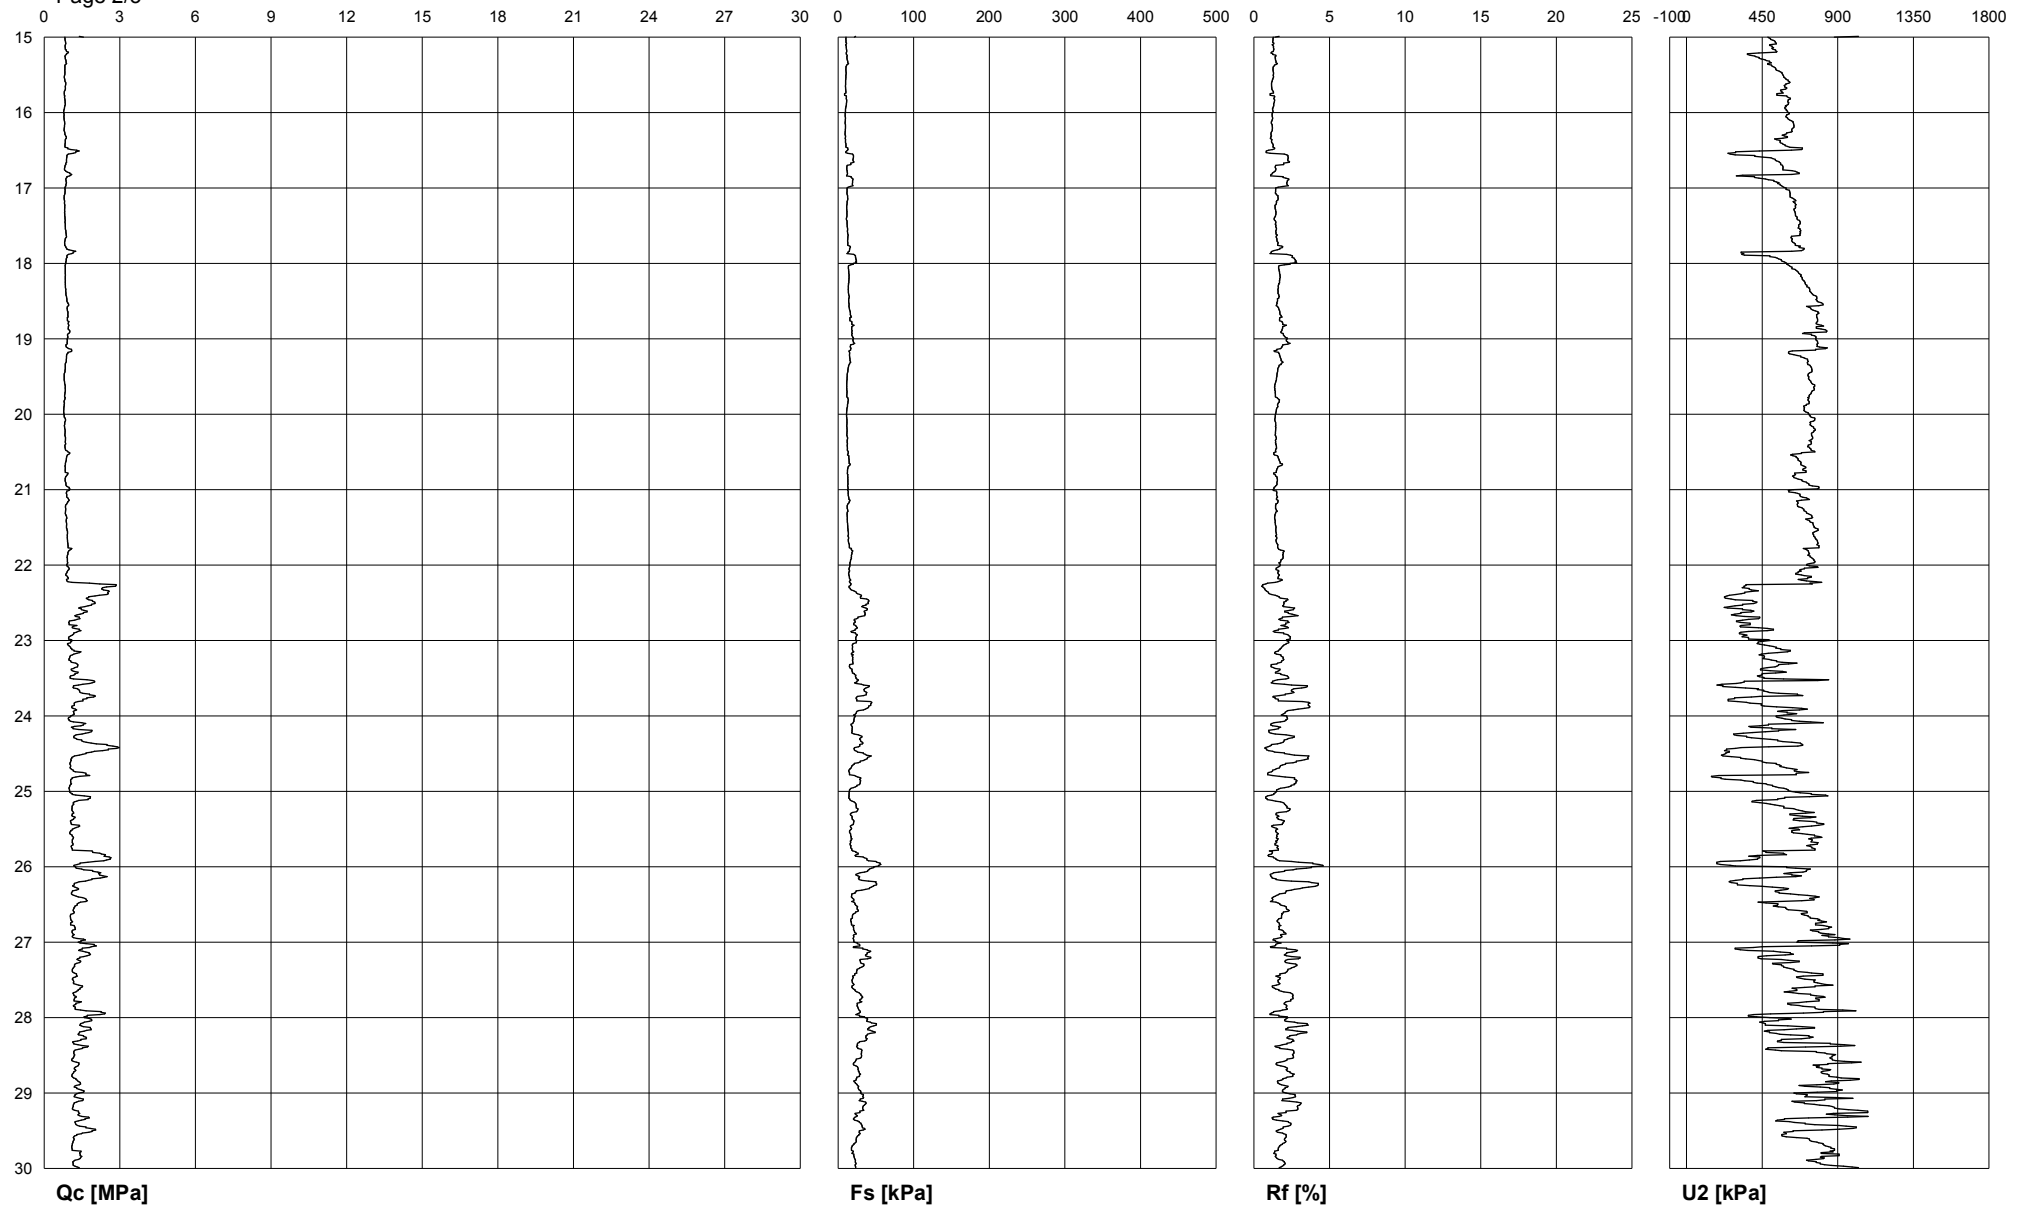
Page 2/3

<b>AS "BMGS"</b>		<b>Commissioner: Piestatnu Nr.2 un Nr.3 rekonstrukcija</b>	
Site: Ventspils brivostas parvalde Locality: Dzintaru iela 51b un 51/3, Ventspils		Test Location: Cpt13 Date: 03.09.2013.	
		Abs. quota [cm]: 250 Prehole [cm]: 200 Hydrostatic Line [cm]: 230

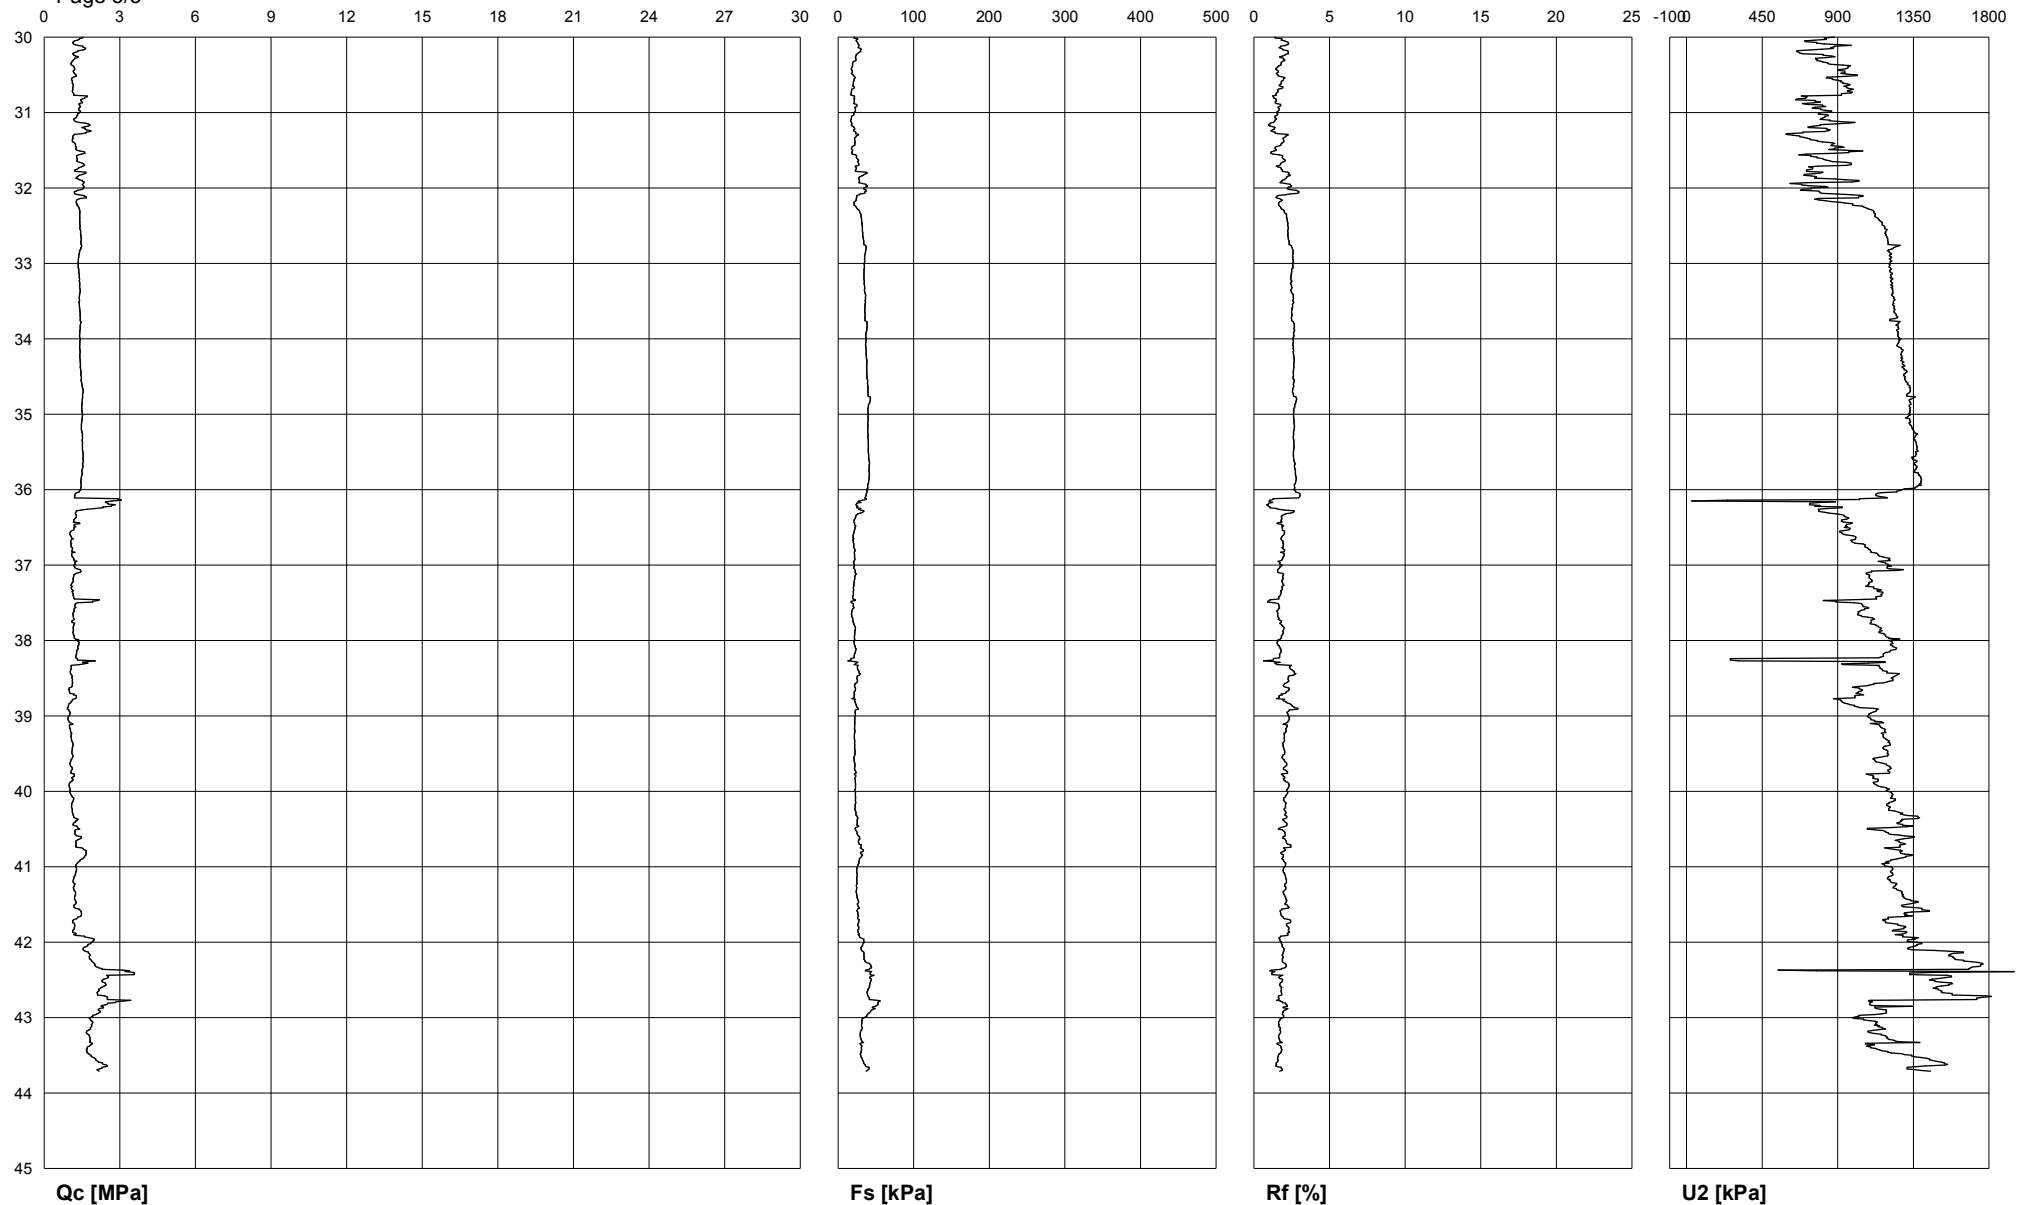
Page 3/3

<b>AS "BMGS"</b>		<b>Commissioner: Piestatnu Nr.2 un Nr.3 rekonstrukcija</b>	
Site: Ventspils brivostas parvalde Locality: Dzintaru iela 51b un 51/3, Ventspils		Test Location: Cpt13 Date: 03.09.2013.	
		Abs. quota [cm]: 250 Prehole [cm]: 200 Hydrostatic Line [cm]: 230
