AS "BMGS"**Commissioner: Piestatnu Nr.2 un Nr.3 rekonstrukcija**Site: Ventspils brivostas parvalde
Locality: Dzintaru iela 51b un 51/3, VentspilsTest Location: Cpt14
Date: 04.09.2013.Abs. quota [cm]: 210
Prehole [cm]: 230
Hydrostatic Line [cm]: 200

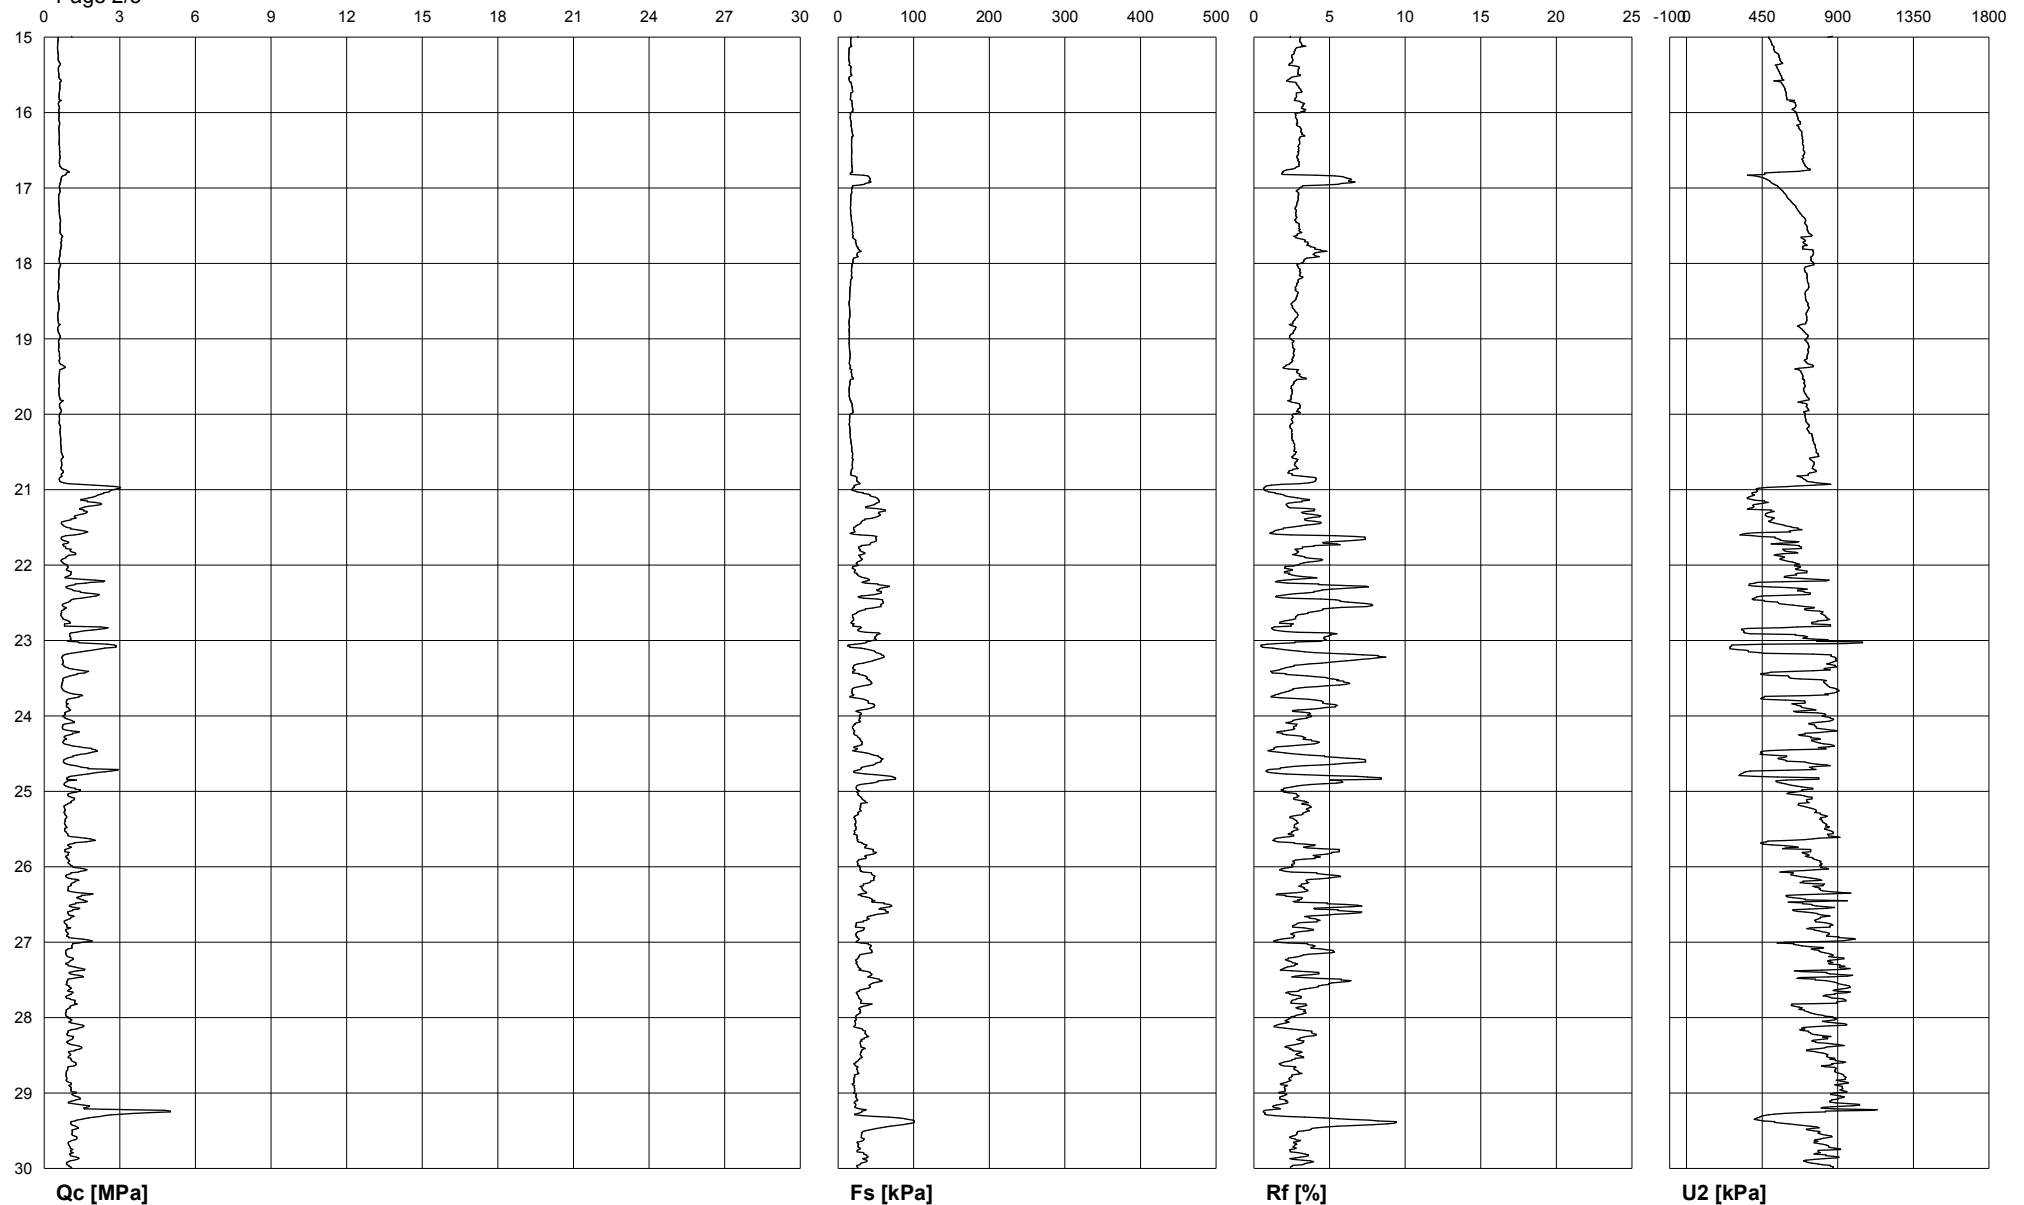
Page 2/3

AS "BMGS"		Commissioner: Piestatnu Nr.2 un Nr.3 rekonstrukcija	
Site: Ventspils brivostas parvalde Locality: Dzintaru iela 51b un 51/3, Ventspils		Test Location: Cpt14 Date: 04.09.2013.	Abs. quota [cm]: 210 Prehole [cm]: 230 Hydrostatic Line [cm]: 200

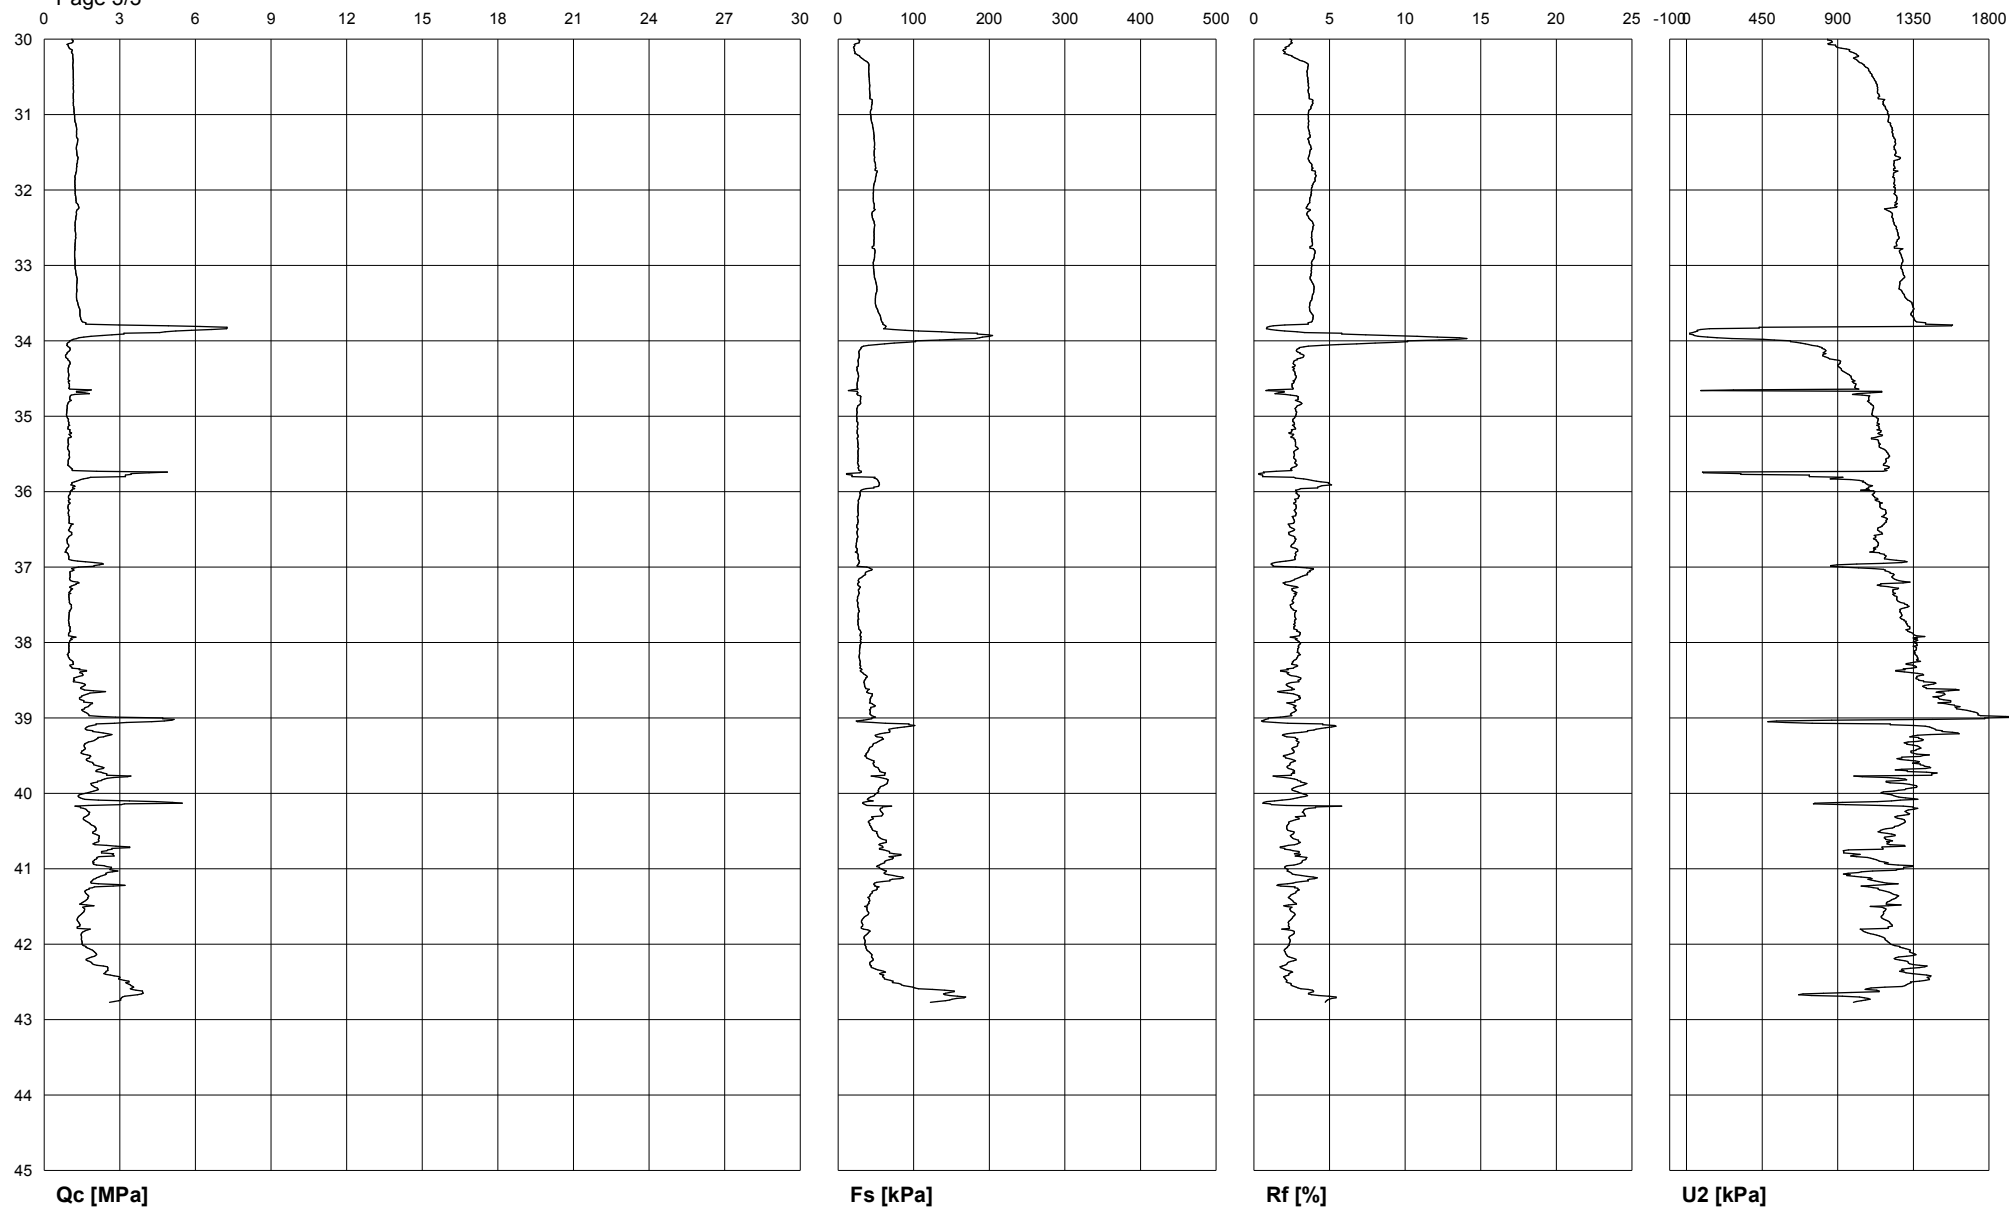
Page 3/3

AS "BMGS"**Commissioner: Piestatnu Nr.2 un Nr.3 rekonstrukcija**Site: Ventspils brivostas parvalde
Locality: Dzintaru iela 51b un 51/3, VentspilsTest Location: Cpt14
Date: 04.09.2013.Abs. quota [cm]: 210
Prehole [cm]: 230
Hydrostatic Line [cm]: 200
